June 28, 2011

Sandy Lamoine  
Administrative Assistant  
Town of Blackstone  
Municipal Office Building  
15 St. Paul Street, Blackstone, MA 01504

### **Americans with Disabilities Act Updated Transition Plan for the Town of Blackstone MA**

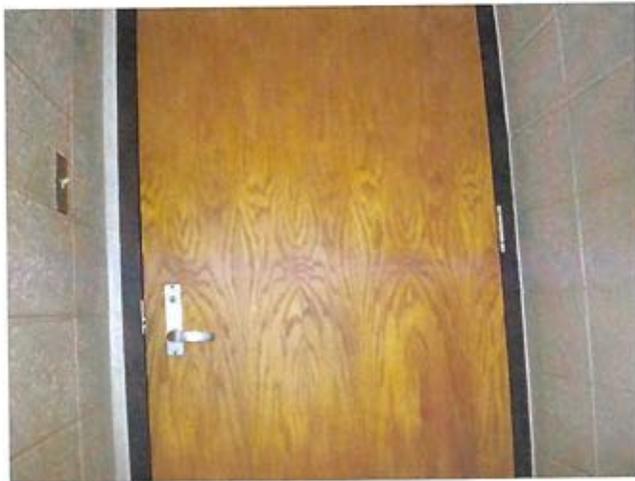
- 1) The following doors 024, 025, 128 and 129 to the men's and women's restrooms on both floors into public spaces do not meet the 18" clear wall space that enable people using a wheelchair or crutches to open the door.

*(ADAAG Section 4.13, New ADAAG Section 404, 521CMR Section 26, Doors & Doorways)*

Remove/replace and reverse swing at doors 024 & 128 (Women's rest rooms). Reconfigure partitions and remove and reinstall doors 025 & 129 (Men's rest rooms)

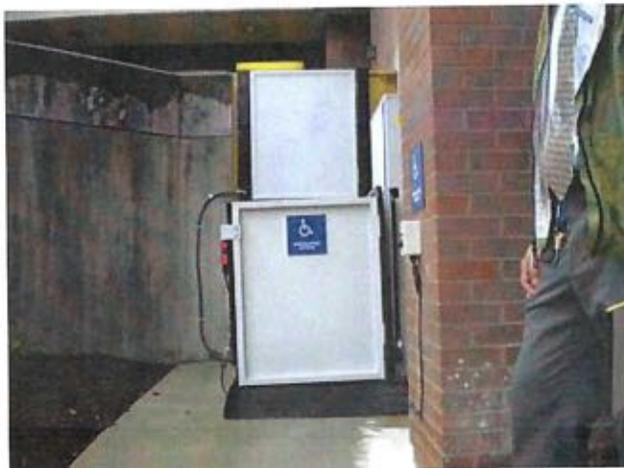
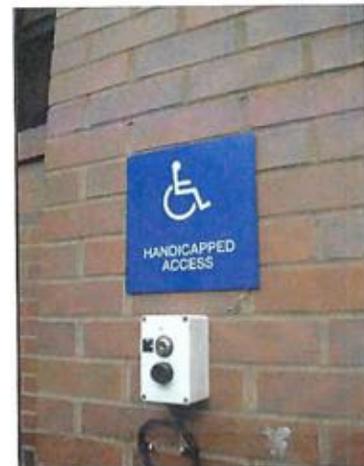
There is now a vertical wheelchair lift to the right of the exterior stairs that has not been maintained very well, nor is there protection from the elements. This will substantially reduce its functional life. In addition, the door that leads into the actual lift platform is locked and police personnel were not able to locate the key. This defeats the purpose of even having the lift. In addition, there was no policy in place that addresses the fact that this lift needs to be available to people who need to use it 24 hours per day, seven days a week.

It is unfortunate that the Town chose to install a vertical lift that requires protection from the elements in addition to routine maintenance to have it operable at all times versus a ramp that would have been virtually maintenance free. Due to the fact that this lift is not able to be used, access to the Police station is only available to people with mobility impairments during the time when the municipal offices and the Senior Center are open. **This is a civil rights violation under the ADA Title II and the Town of Blackstone could be vulnerable to a lawsuit through the U.S. Department of Justice and could be responsible for monetary damages.**

addition, it is highly recommended that a covering is placed over and around the lift to protect it from the outdoor elements. This could substantially extend its useful life.

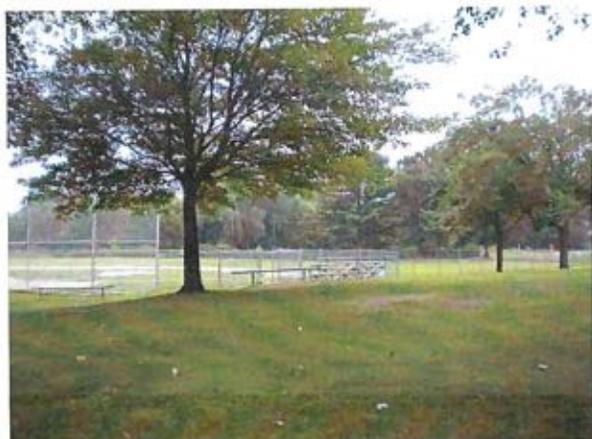
No walkway improvements have been made.

Views of Terbesi Park showing lack of paved paths of travel.

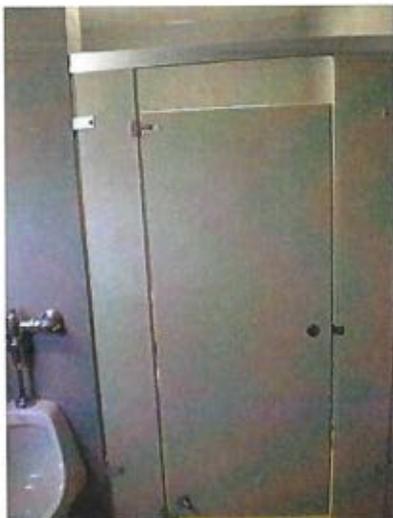
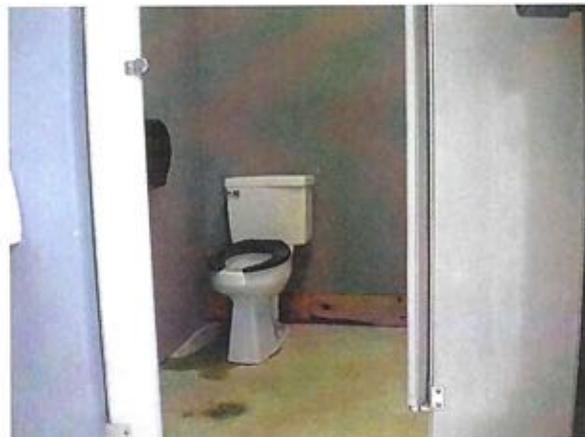
In the women's restroom, there is another toilet stall that is compliant in its dimensions and the stall doors have a compliant clear opening of 32". However, the stall is not accessible because the door opens into the stall. To remedy this, reverse the door swing so that it opens out instead of in.

*ADAAG Section 4.13 Doors*

Replace narrow stall doors with ones that provide a minimum 32" clear opening.

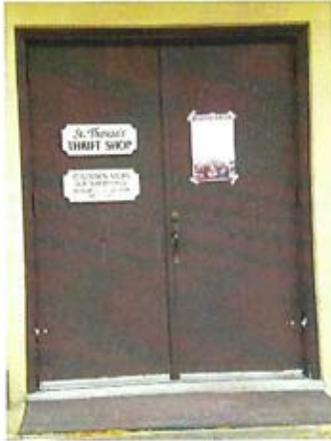
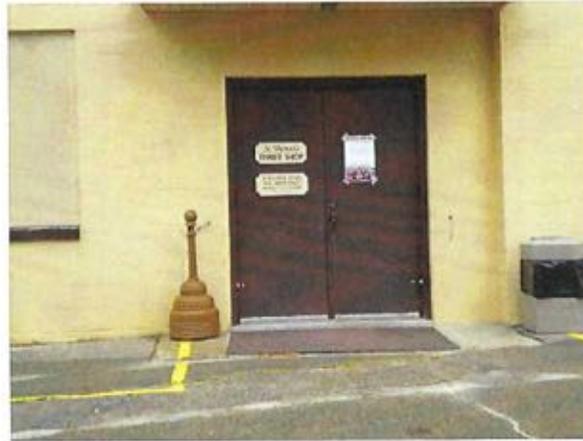
*(ADAAG Sections 4.5, 4.13 & 4.14, New ADAAG Sections 303,309 & 404 521CMR Sections 22 & 26)*

- Add asphalt and grade the surface so that there is a smooth transition from the parking lot surface to the concrete platform entrance with a slope of 2% (1:50) or less.
- Install an automatic door opener that opens both doors.
- Replace the doorway with one that has a minimum of 32" clear opening space. The clear opening is measured from the face of the stop on the latch side to the face of the door when it is open 90 degrees. A standard 36" doorway provides the compliant clear opening requirement. In addition, make sure the door hardware is operable with one hand and a closed fist between 36" to 48" AFF. Lever-operated, push-type mechanisms and U-shaped handles are acceptable designs.
