**RE: Evaluation of Repairs for Bridge No. B-13-001**  
**Blackstone, Massachusetts**  
Pare Project No. 24061.00

At the request of the Town of Blackstone (Town), Pare Corporation has evaluated Bridge No. B-13-001 carrying Bridge Street over the Blackstone River. The bridge, constructed in 1955, is a 175-foot two span structure with steel stringers and a concrete deck supported on cast-in-place concrete substructures with spread footings. It carries two lanes of traffic, one sidewalk, and metal railings. The Town is the owner and is responsible for maintaining the bridge. To identify needed repairs and help with planning for required maintenance, the Town has requested that existing conditions be reviewed to determine the scope and extent of recommended repairs to the various bridge components. An Opinion of Probable Construction Cost (OPCC) for identified repairs was also requested.

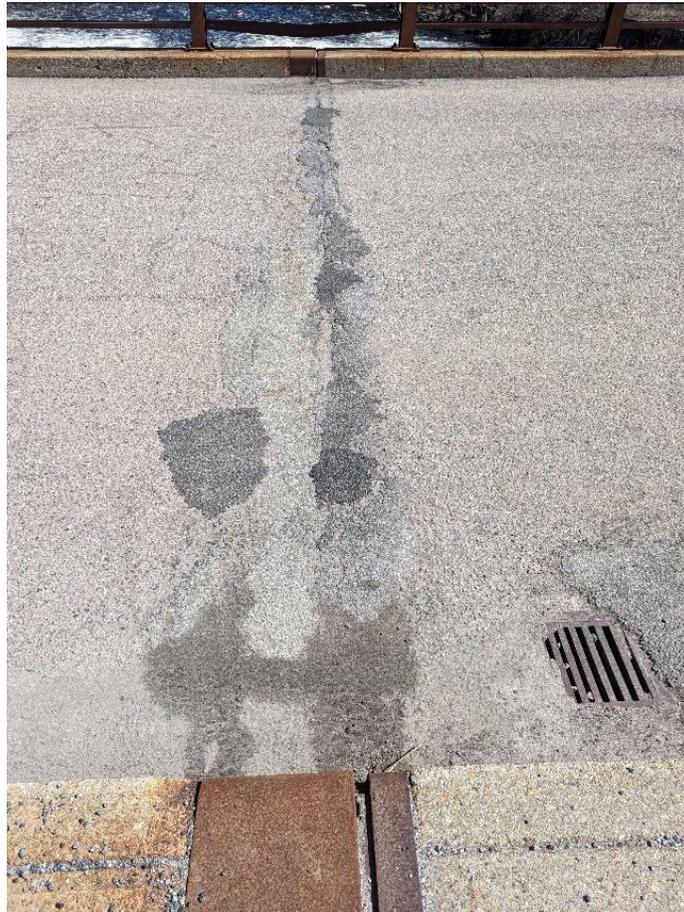
**Photo 1: Wearing Surface at Bridge Joint Over Pier**

- The deck wearing surface is a two-inch bituminous concrete wearing surface with transverse, longitudinal, and map cracks throughout. Both spans have numerous bituminous concrete patches and small potholes. Notably, the pavement at the paved-over pier joint has moderate to wide transverse and map cracking. Typical wearing surface conditions are shown in Photos 1 and 2.

It is Pare's understanding that the Town intends to mill the existing wearing surface to the bridge deck and repave the bridge. In conjunction with this operation, we recommend the following:

- Install a waterproofing membrane on the concrete deck before repaving.
- Install an asphaltic plug roadway joint and seal the sidewalk joints at the pier. Sawcut and seal joints at the pavement at the abutments. These joints will allow for movement and reduce the potential for cracking, leakage, and future patching, especially at the pier.

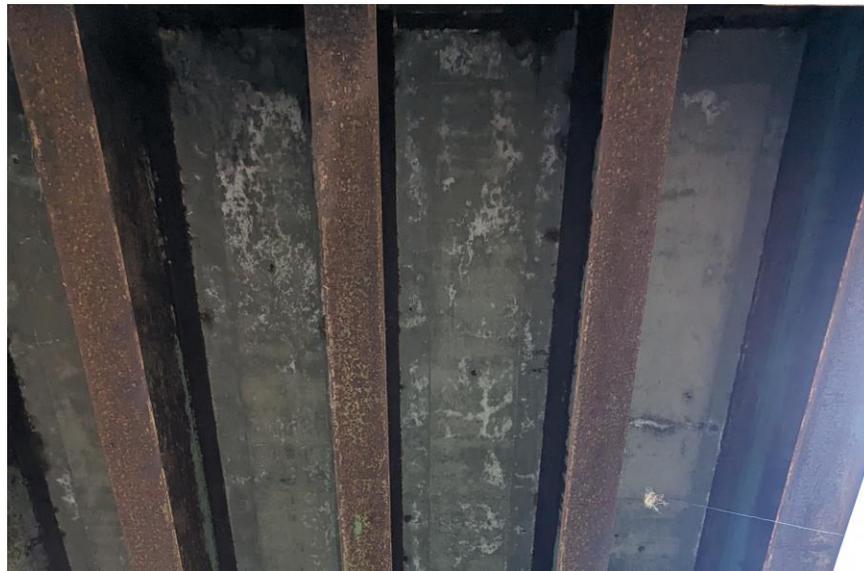
**Photo 3: Typical Deck Conditions**

- The deck underside has many full width transverse hairline cracks with efflorescence ranging from light to heavy. Typical deck conditions are shown in Photo 3.
- The steel beam ends and bearings at the abutments are in good condition. Only Beam #10 at the North Abutment exhibited deterioration with light rust flaking. The bearings have heavy surface rust with no significant section loss.
- The steel beam ends at the pier are in significantly worse shape than those at the abutments, as detailed in the Special Member Inspection Report, dated July 5, 2022. Ten beam ends at the pier exhibit significant section loss in the web and bottom flanges. Typical steel conditions are shown in Photo 4.

The extent of deck repairs required is difficult to estimate. Based on conditions observed on the bottom of the deck and in the wearing surface, it is reasonable to assume a portion of the deck requires repair. A more thorough evaluation can be made as part of the mill and overlay process described above. For the purposes of this evaluation, and based on observable conditions, we estimate up to 25% of the deck area may require partial or full-depth repairs in the future. Typical deck repair details are shown in Figure 2.

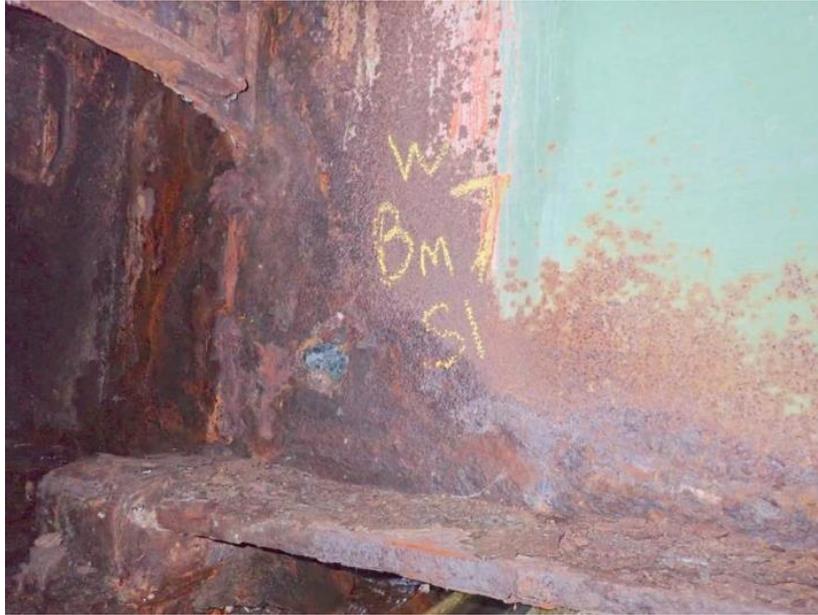
**Photo 4: Typical Beam-End Conditions at Pier  
(Span 1, Beam 7 at Pier Shown)**

The existing structural steel deterioration at the pier is the most critical condition observed on the structure. Further deterioration could result in a reduced load capacity or even bridge closure until repairs can be completed. Typical beam-end repairs consist of installing temporary shoring, removing existing paint and rust, patching the remaining steel with an epoxy filler, and bolting repair plates and angles to the affected areas to restore the load-carrying capacity. Typically, the repair plates, angles, and bolts are galvanized for added protection. An example of a typical beam-end repair detail is shown in Figure 1 below.

While the paint system throughout this bridge is in poor condition, much of the steel exhibits only minor surface rust. The exception is at the pier, where significant section loss has occurred. Following beam end repairs, Pare recommends painting the structure. There are significant cost implications to this recommendation, as it is expected to cost over \$2 million for a complete painting based on recent MassDOT project bids. While complete painting is recommended to protect the entire structure, a more targeted approach could also provide significant benefits. Painting only the steel within the first few feet of the pier where the bulk of deterioration has occurred would provide significant benefits without the cost of painting the entire structure and is recommended should full painting not be a viable option. Painting the steel at the abutments in conjunction with painting the steel at the pier would also provide additional protection where surface rust and paint flaking is heavier than along the span.

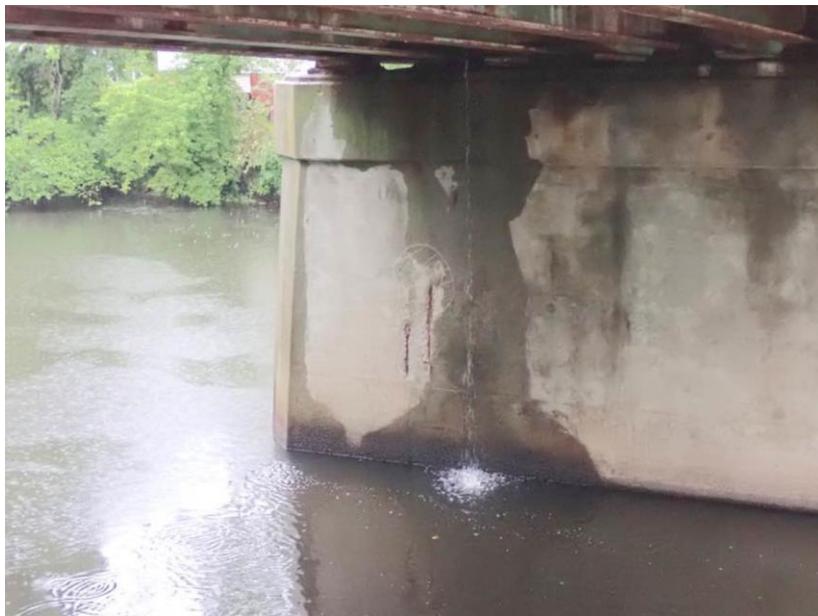
**Photo 5: Spall at Pier**

- The concrete abutments have minor spalls with exposed steel reinforcement, cracking, and efflorescence, but otherwise appeared to be in generally good condition. No spalls were noted.
- Based on the latest inspection report, the concrete pier has abrasion at the water line and a single 5'-4" high  $\times$  2'-6" wide  $\times$  up to 1" deep spall with exposed steel reinforcement (see Photo 5).

While no significant concerns were identified on the abutments and pier. Installation of a protective coating on the abutments and pier will seal small cracks and provide an extended service life for these components. Any cracks too wide to seal with a protective coating can be sealed with urethane prior to applying the protective sealer. One spall observed at the pier and described in the latest inspection report may require repair, though it is a shallow spall and not critical at this time.
