July 3, 2024

RE: Evaluation of Repairs for Bridge No. B-13-009
Blackstone, Massachusetts
Pare Project No. 24061.01

STRUCTURES INSPECTION FIELD REPORT

BR. DEPT. NO.
B-13-009

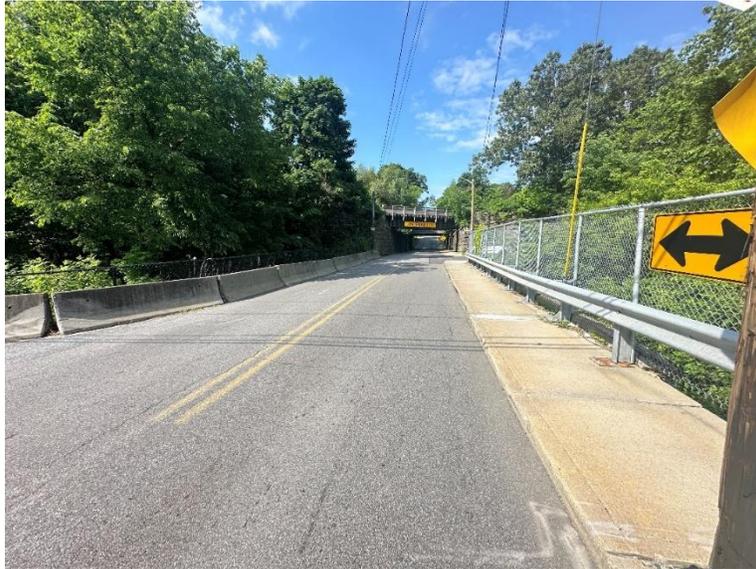
- The deck wearing surface is a bituminous concrete pavement with minor cracking. Typical wearing surface conditions are shown in Photo 1.

Photo 1: Wearing Surface Over Bridge (Facing West)

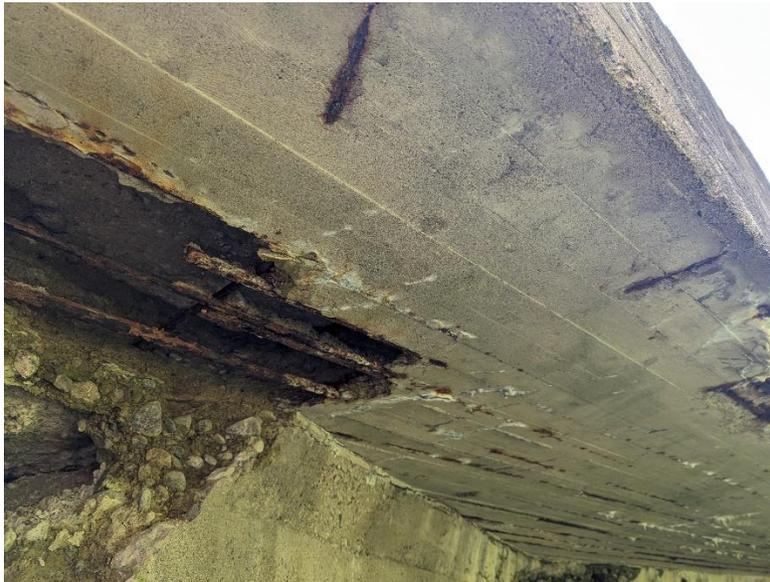
- The sidewalk underside has many surface spalls with heavily corroded exposed reinforcement. There are several deep spalls that show exposed rebar and a steel plate. See Photo 2.

Photo 2: Underside of Sidewalk

The deteriorated concrete visible on the underside of the sidewalk is the most critical condition observed on the structure. Further deterioration could result in a reduced load capacity or even sidewalk closure until replacement is completed. The extent of deterioration observed makes preservation of the existing concrete superstructure impractical. Typical sidewalk replacement would include demolition of the existing sidewalk, casting a new sidewalk structure in-place or installing a precast sidewalk structure, substructure repairs and modifications, relevant traffic control for the work, and a new bridge railing. It is anticipated that the pier at the midpoint of the sidewalk would be acceptable for re-use with repairs and modifications. As part of this repair, Pare recommends removing and replacing the deteriorated concrete at the wingwalls and spandrel wall above the arches.

Concrete Sidewalk Replacement

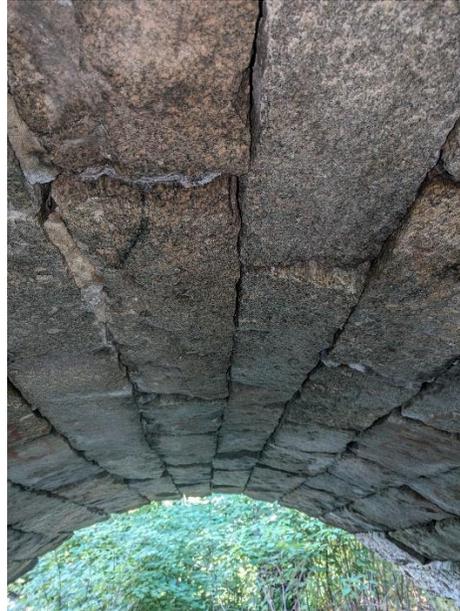
- The masonry arch was in overall good condition, with isolated areas of leakage, light efflorescence, and minor cracking. See Photo 3.

Photo 3: Masonry Arch

The arch is in acceptable condition, with some deterioration noted. Pare recommends pointing and grouting the masonry to maintain its current condition and prevent potential future deterioration. This repair is considered non-critical at this time.

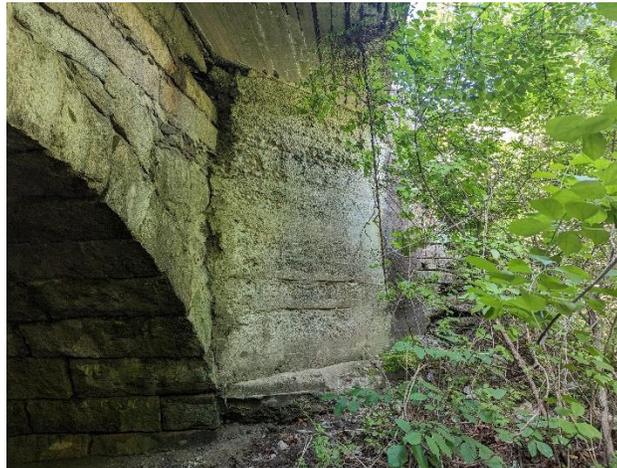
- The northwest wingwall consists of cast in place concrete and contains spalls along the edge of the channel wall and wingwall. See Photo 4.

Photo 4: Northwest Wingwall

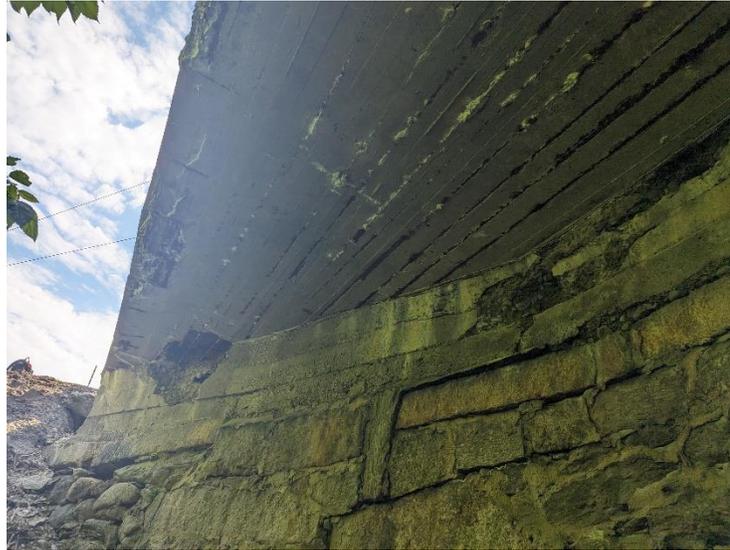
- The northeast wingwall is made of masonry with a cast in place concrete cap. The wingwall has a cracked stone and a large, scaled area under the sidewalk slab, as well as a large void underneath the approach pavement. See Photo 5.

Photo 5: Northeast Wingwall

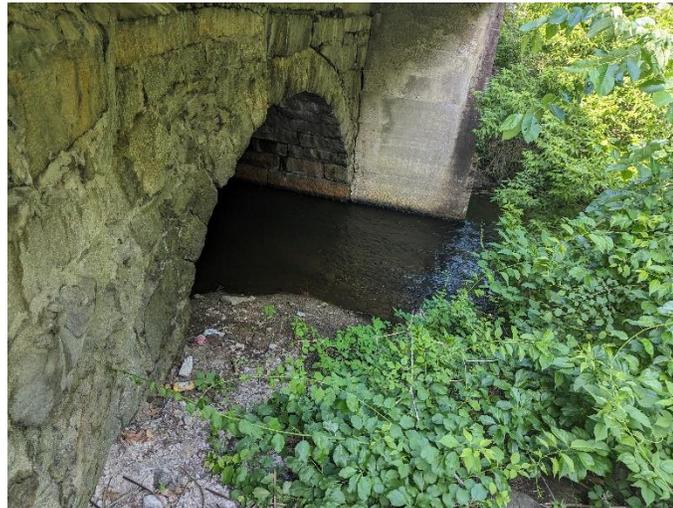
- The northeast, northwest and southeast embankments have sloughed into the channel constricting flow with heavy vegetation growth. For typical embankment conditions see Photo 6.

Photo 6: Northeast Embankment

It is Pare’s understanding that the Town has expressed interest in installing concrete wingwalls at the corners of the bridge. However, significant costs are associated with the installation of wingwalls. Typical cast-in-place wingwalls at this bridge would require either pile or spread footings, control of water, and cast-in-place reinforced concrete. As a lower-cost alternative Pare recommends providing riprap as slope

protection at the embankments to restore the slopes and prevent future embankment erosion to maintain channel conditions. An example of a riprap slope detail is shown in Figure 2.

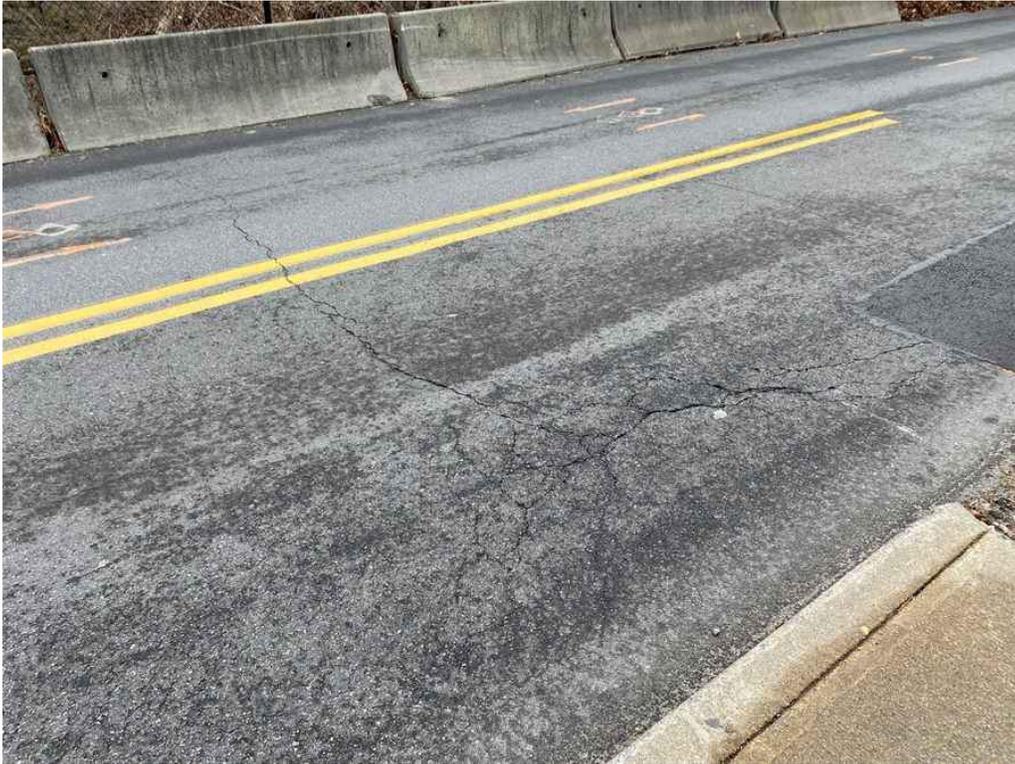
At the west end there is an almost full width light to moderate transverse crack. Westbound lane at the west end there is a 12' long x 3' wide area of light to moderate map cracking extending into the west approach. **See Photo 1.**

Photo 1: West end of the wearing surface.

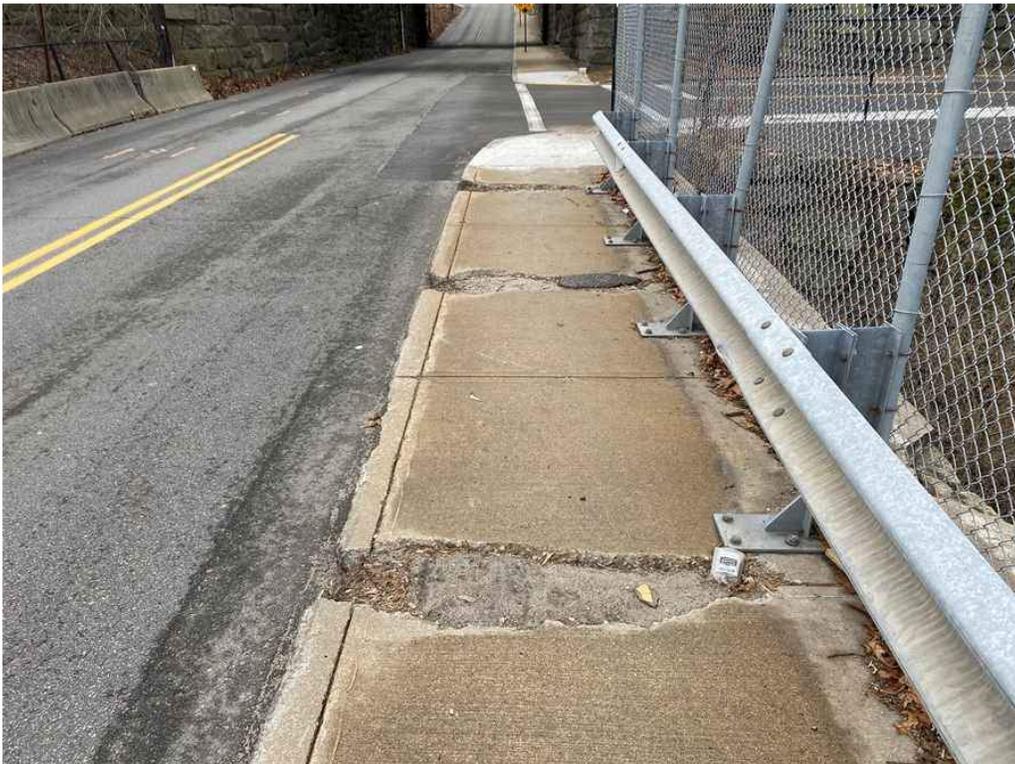
- 6 full depth spalls, up to full width (5') x up to 1'-10" long x 3" deep filled with soil. **See Photo 2.**

Photo 2: Spalls to the top of the north sidewalk.

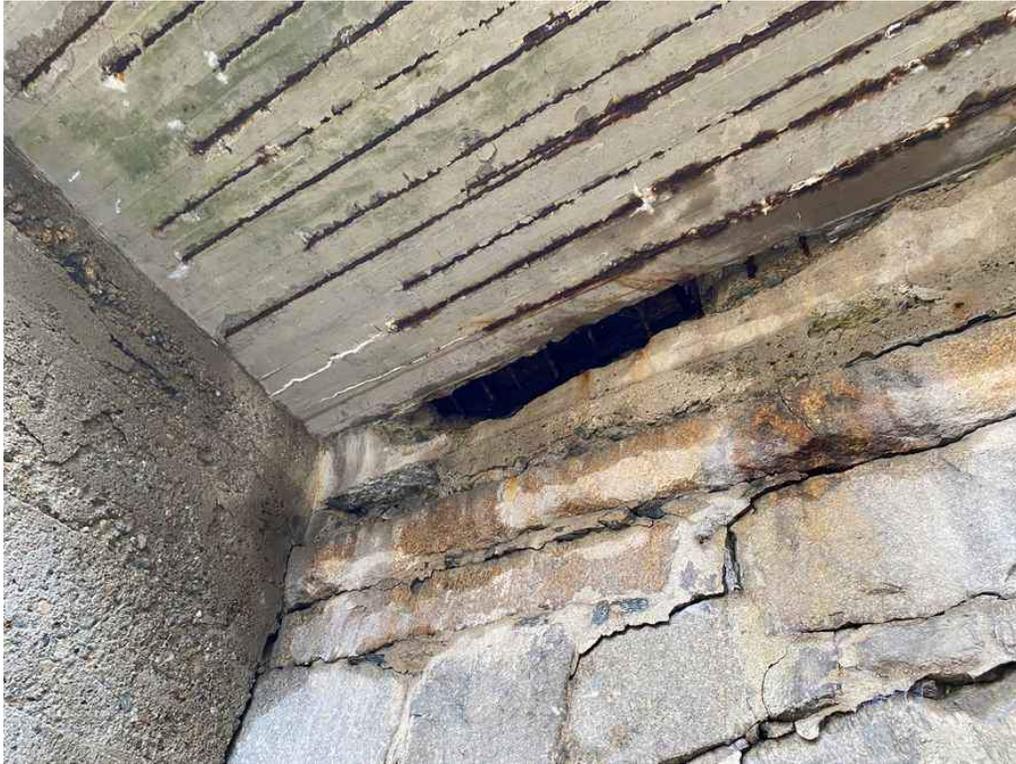
- Span #1 at the spandrel wall interface near the pier has a 6' long x 10" wide x 5" deep spall with a 3' long x 9" wide hole exposing heavily rusted slab reinforcement and a steel plate covering the hole from the top. (The steel plate(s) are buried under the new pavement). **See Photo 3.**

Photo 3: Span #1 underside of the north sidewalk near the pier.

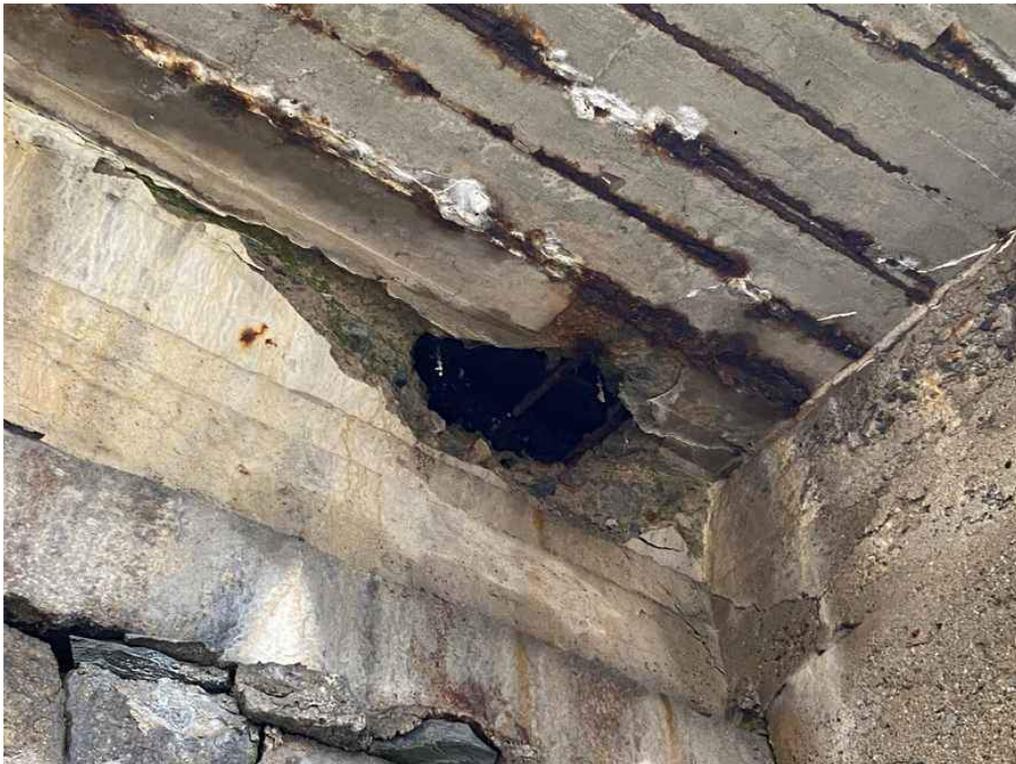
- Span #2 along the interface with the spandrel wall at the pier has a 2' long x 10" wide x 5" deep spall exposing heavily rusted reinforcement. Within this spall there is a 1.25' x 8" hole with a steel plate over it same as in span 1. **See Photo 4.**

Photo 4: Span #2 underside of the north sidewalk near the pier.

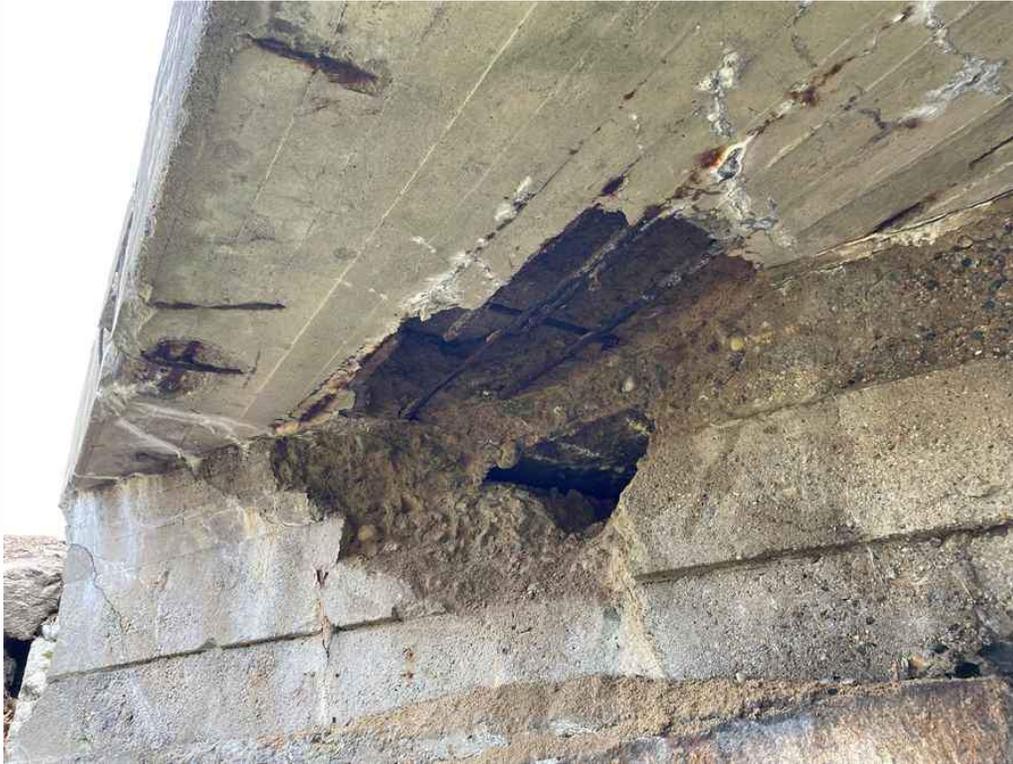
- The east end of the slab which rests on top of the masonry wingwall at 4' from the end has a 4' long x up to 1'-6" wide x full depth spall exposing heavily rusted reinforcement and underside of the concrete sidewalk. **See Photo 5.**

Photo 5: Underside of the north sidewalk at the east end. Note spall to the northeast wingwall and hole.

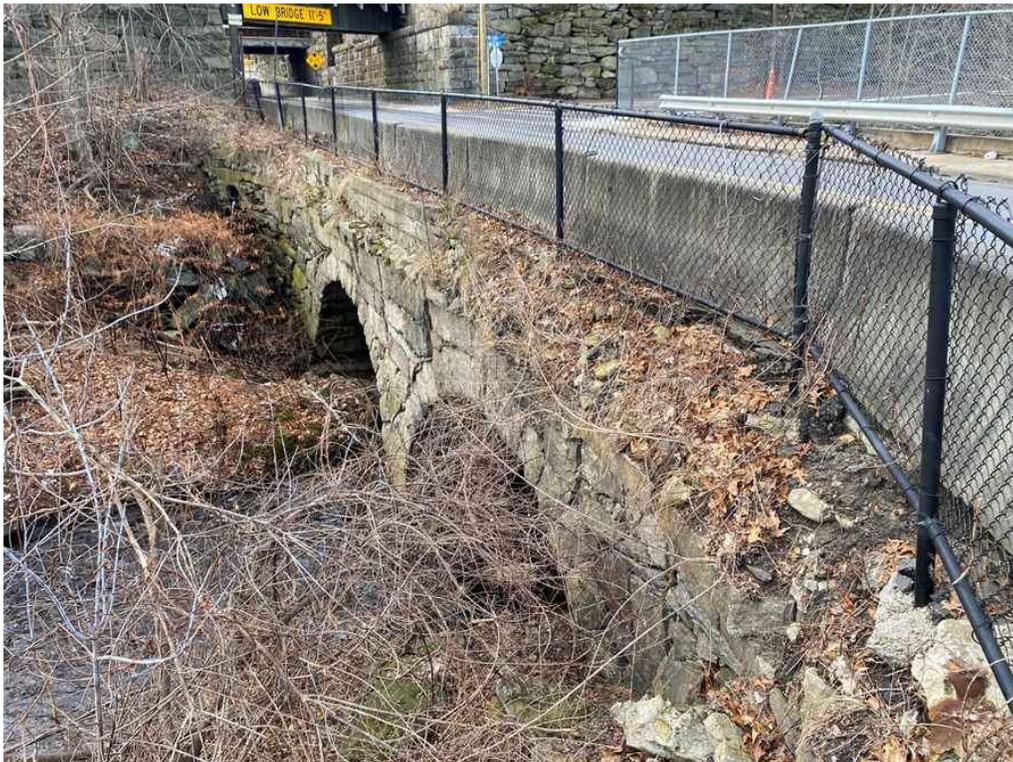
South parapet has severe concrete deterioration in many areas throughout with a 21' long x full height x full width area at the east end that has been previously dislodged by collision damage (reported on 5/17/05). **See Photo 6.** There is a row of Jersey barrier and chain link fencing in front of the parapet/coping.

Photo 6: Heavily deteriorated south parapet/coping.

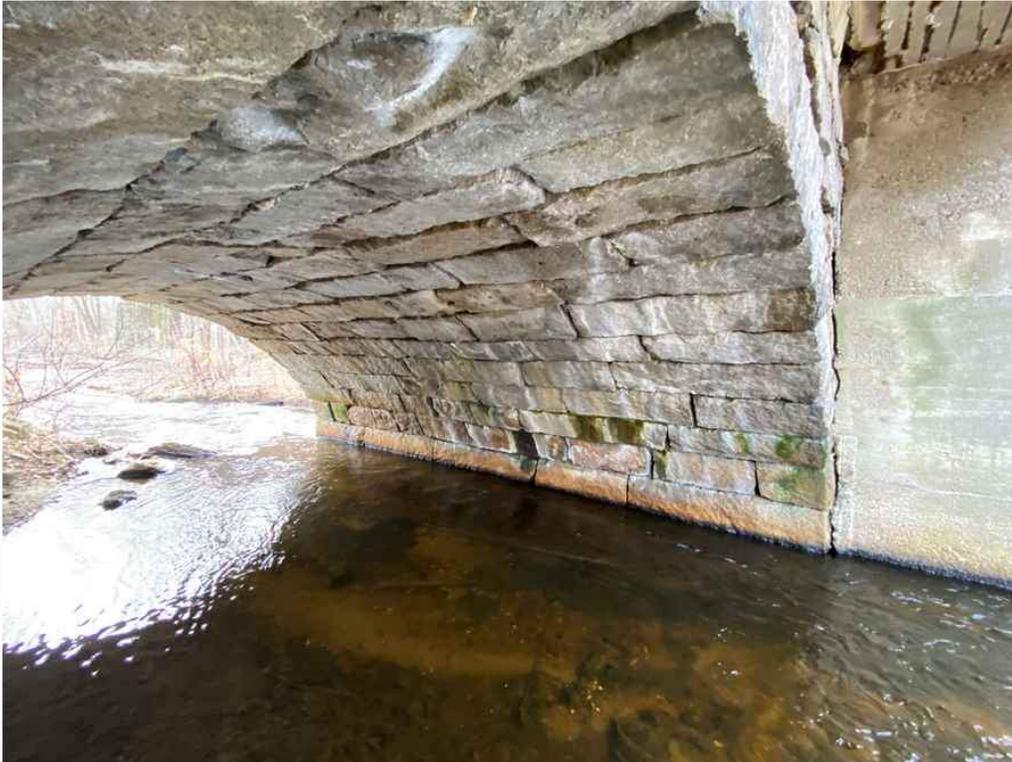
Both arches consist of large dry laid granite blocks. There are isolated areas of leakage and light efflorescence through both arches. **See Photo 9.** In the east arch, the south end of the 2nd and 4th courses from the pierwall each have one stone with a full height minor crack. **See Photo 10.**

Photo 9: Typical arch condition. Span #2 shown

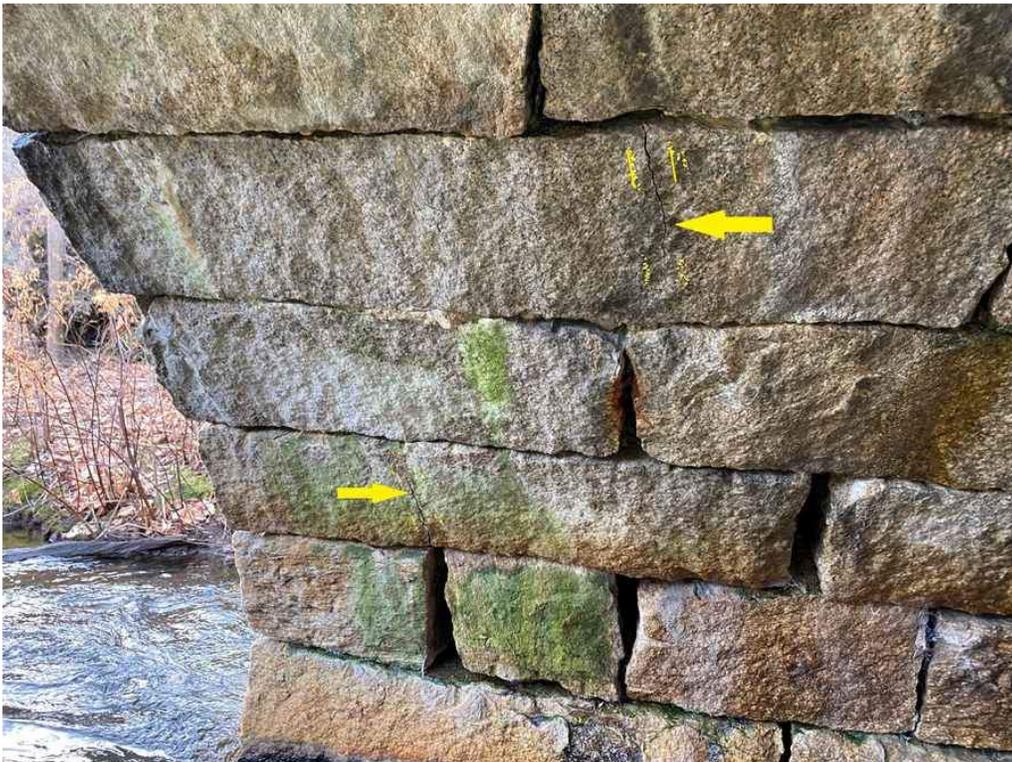
Photo 10: Cracks to the arch in span #2 at the pier wall.

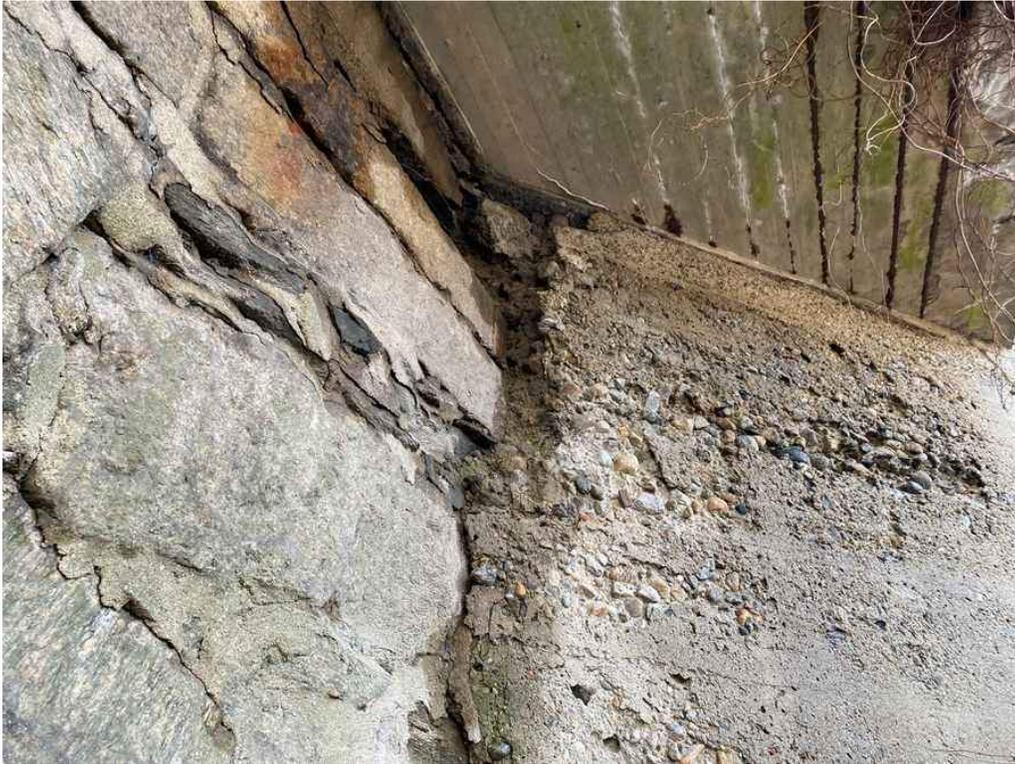
The northwest concrete wingwall has heavy scaling and concrete deterioration throughout. **See Photo 15.**

There are spalls along the edge of the wall at the interface with the channel wall and wingwall up to 7' high x 4' wide x 1' deep.

Photo 15: Northwest wingwall.

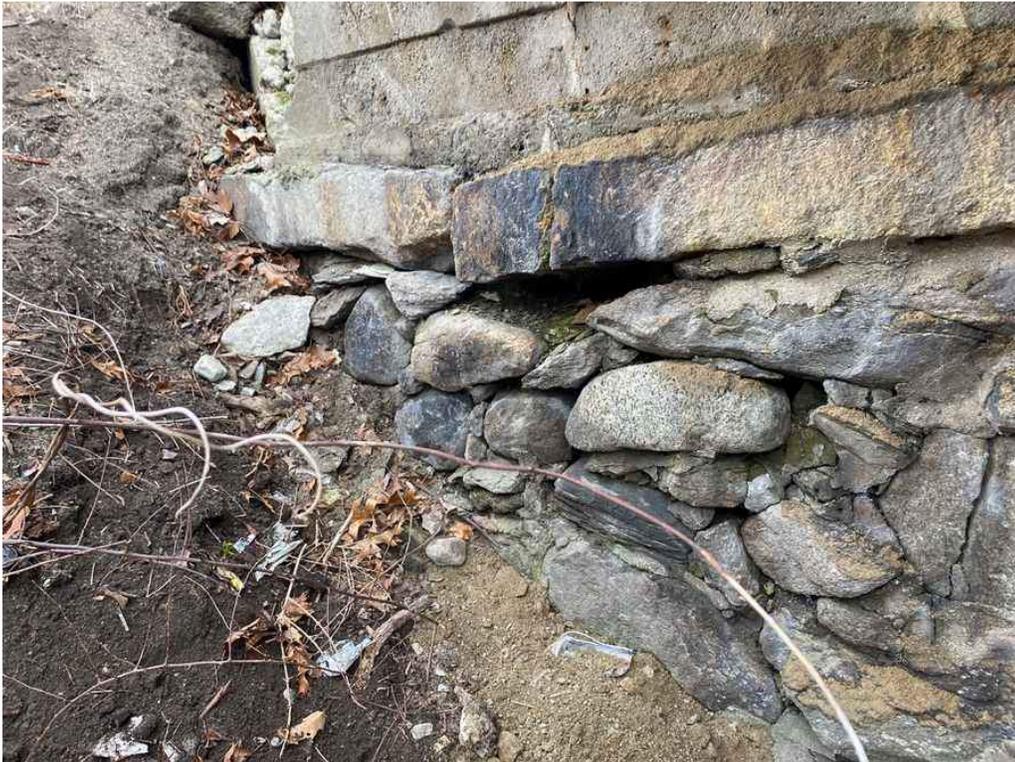
The northeast wingwall, 4' from east end near the top of the slope has one cracked stone. **See Photo 16.** At the top of the wingwall in the concrete portion there is a 4'-6" wide x up to 2' high x full depth scaled area under the sidewalk slab. **See Photo 5.** This has exposed a large void underneath the approach pavement. See Item 60.1.i - Embankment Erosion for additional comments.

Photo 16: Northeast wingwall.

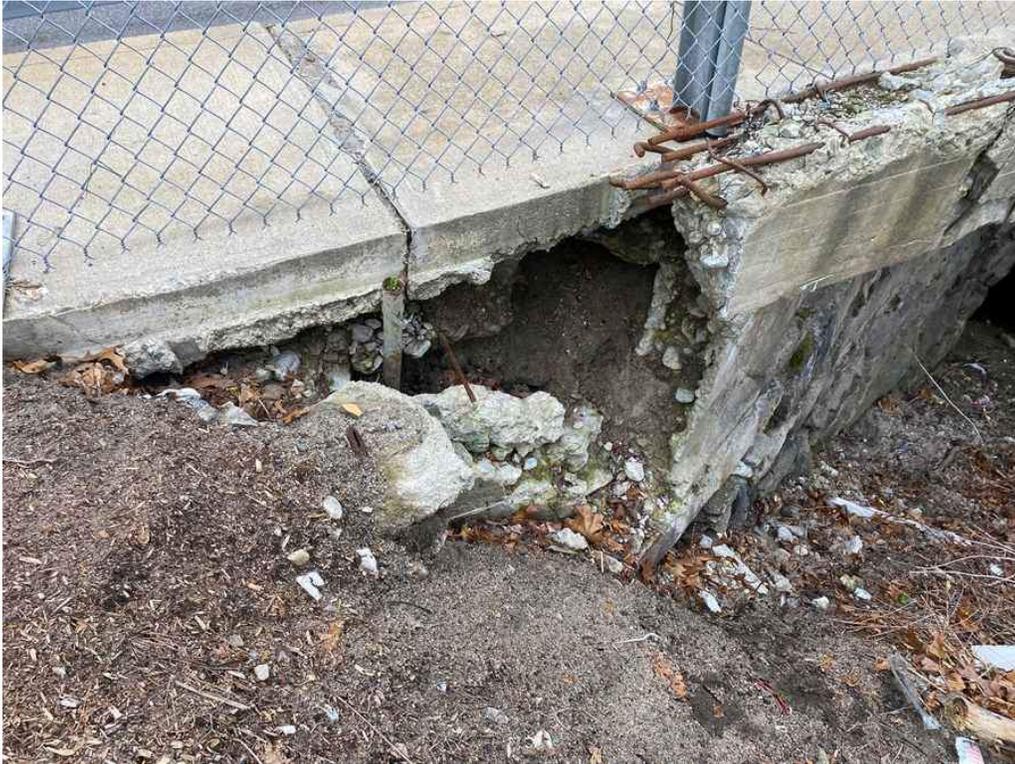
Photo 17: Erosion behind the northeast wingwall.

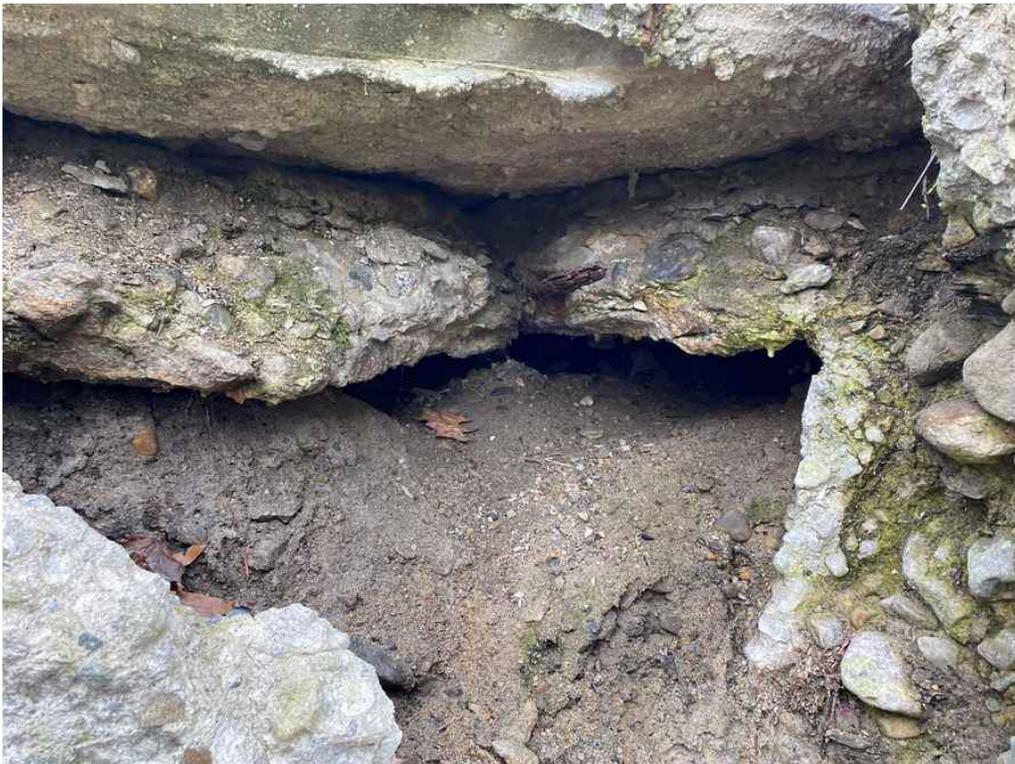
Photo 18: Close up of the erosion at the northeast wingwall.
