## **Town of Blackstone ADA Transition Plan Updates October 2017**

### **Municipal Center – 15 St. Paul Street**

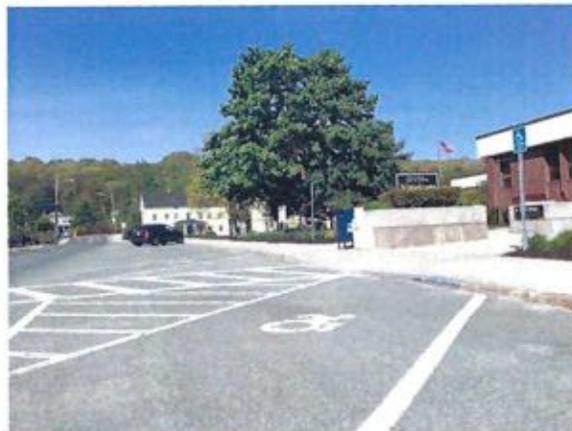
**Accessible Parking Spaces in Front of the Municipal Center**

- 1) Neither above-ground handicap parking sign has the words "van accessible" posted on it.

**ADAAG Sections 208.2.4 – Van Parking Spaces & 502.6 – Identification.**

**AAB – Sections 23.4.7 – Van Accessible Spaces & 23.6.3 – Van Accessible Signage.**

**Action Item** – Install "Van Accessible" sign on one of the handicap parking sign posts.

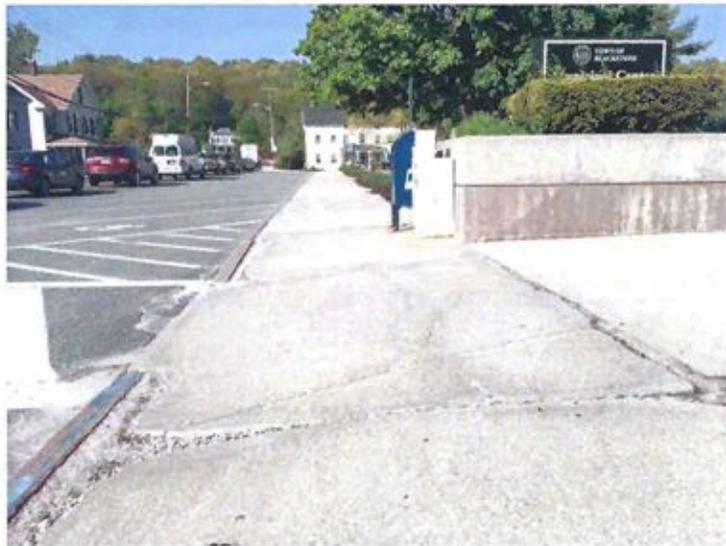
### **Curb Cut at Accessible Parking Spaces on St. Paul Street**

The curb cut in front of the Municipal Center on St. Paul Street between the handicap parking access aisle exceeds the maximum allowed running slope of 1:12 (8.3%) with measurements of 9.5%, 10.8% and 13.2%

- 1) Running slope exceeds 1:12 (8.3%) with measurements of 9.5%, 10.8% & 13.2%

**ADAAG – Sections 405.2 - Ramp Slope & 406 - Curb Ramps.**

**AAB – Section 21.3 – Curb Cut Slope**

**Action Item** – Regrade curb cut to 8.3% or less.

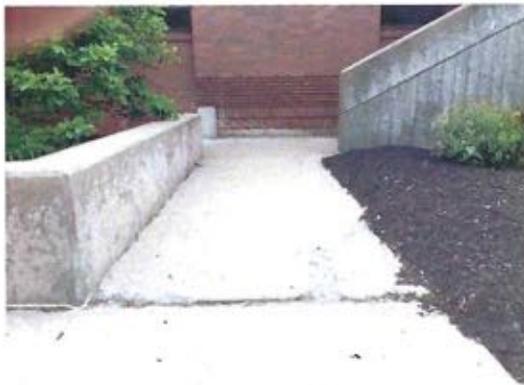
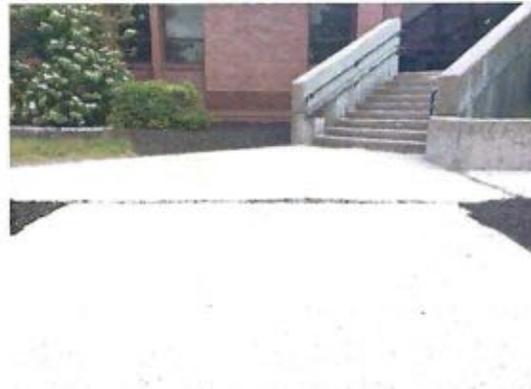
- 2) There are a couple of change in surface levels in the walkways leading to the front entrances of the Municipal Center. Walkways, especially when they are supposed to be accessible routes must be firm, stable, slip resistant and free of changes in surface levels over ¼ of an inch. These walkways are compliant in slope and width

**ADAAG Section 303 – Changes in level**

**AAB Sections 20.10 – Changes in level and 29.2 – Surface Level Changes**

**Change in surface levels on the front walkways of the Municipal Center**

**Action Items** – Fill small bumps and breaks with patches.

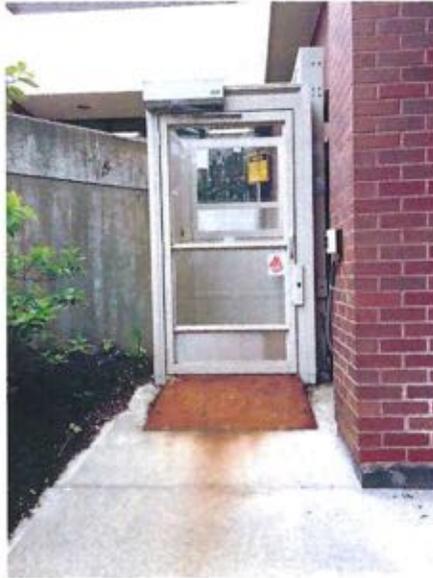
Both the walkways from St. Paul Street to the front of the Municipal Center First Level, Police Station and Fire Station lead to a set of stairs. There is a lift located at the stairway leading to the Police and Fire Departments. However, the lift door is locked so a person with mobility impairment cannot use it to gain access to the building. This was pointed out when the Center for Living & Working conducted an updated ADA Transition Plan in 2011. At that time, nobody at the Police Station could find the key. In 2017 when the lift was tested during this survey, it was not operational at all from the top level.

### **Vertical Lift to the Police & Fire Stations**

This is a serious access and civil rights violation for persons with disabilities because there are many situations where a person with a disability would need access to the Police and Fire Departments after 4PM such as a domestic violence situation or a need for a restraining order. The Center for Living & Working pointed this out in 2011 when they conducted that ADA Transition Plan Update.

**Action Item** – Replace the lift with a compliant ramp that will lead to the Police & Fire Department entrance. This would enable all people access 24 hours per day, seven days per week, the hours that these departments operate.

The requirements for this ramp are 4 feet of clear space between handrails. The handrails shall be continuous on both sides of the ramp, 1-1/4" to 1-1/2" in outside diameter, and round or oval in shape; handrails to be provided in pairs, one at a height of 34" - 38" above the ramp surface and the lower handrail at a height between 18" and 20"; handrails to be 1-1/2" from the mounted surface; handrails should extend 12" beyond the bottom of the ramp. The ramp shall not exceed a running slope of 8.3% nor a 2.0% cross-slope. A 60" x 60" level area at the ramp base and top is required.

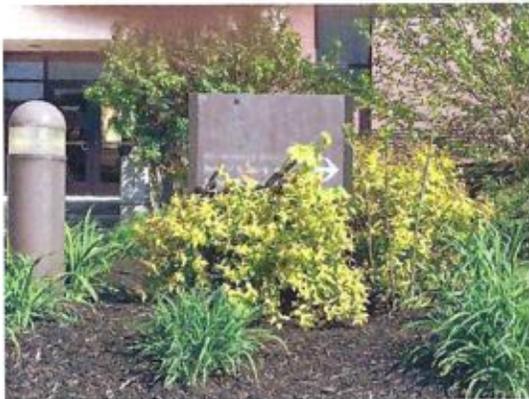
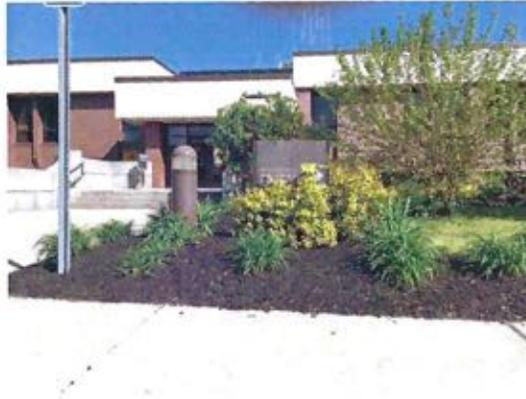
- 3) The directional signage to the accessible entrance at the rear of the Municipal Center is blocked by decorative plants forcing people not familiar with the building to take a long walk to the entrance they can get into the building

#### **Directional Signage to accessible entrance blocked by decorative plants**

**Action Item** – Cut back the plants so that the sign is completely visible

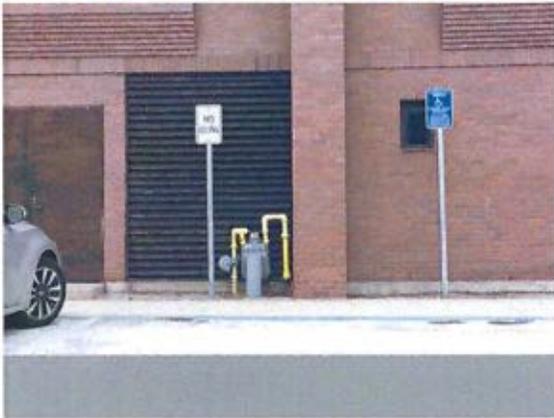
- 1) The van accessible parking space with the compliant access aisle signage needs to be rearranged and lacks the words "Van accessible"

#### **ADAAG – Section 502.6 (Identification)**

## **AAB – Sections 23.2.2 (Van Accessible Spaces) and 23.6.3 (Signage)**

**Improperly Placed Signage**

**Action Item** - Switch the "no idling" sign with the Sign bearing the Universal Symbol of Access and add the words "Van Accessible"

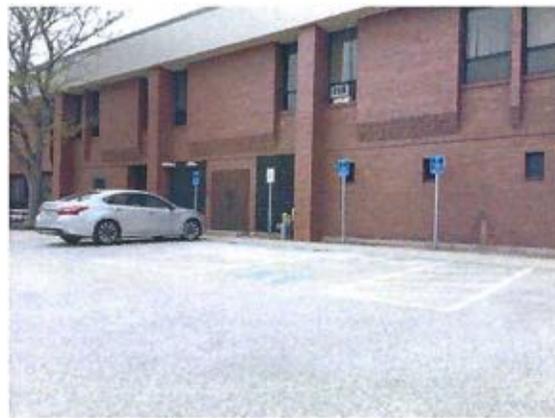
There are three designated handicap parking spaces located here out of a total of 50 which is the compliant amount that needs to be provided. The parking lot is flat, so there are no running or cross slopes to be concerned with. Each handicap parking space has an above-ground sign permanently mounted at the head of each space. There are compliant car and van accessible access aisles. However there are a couple of easily fixable violations that need to be addressed. The parking lot lines and access aisles striping is fading and will need to be painted again soon.

**Accessible Parking at Rear Entrance**

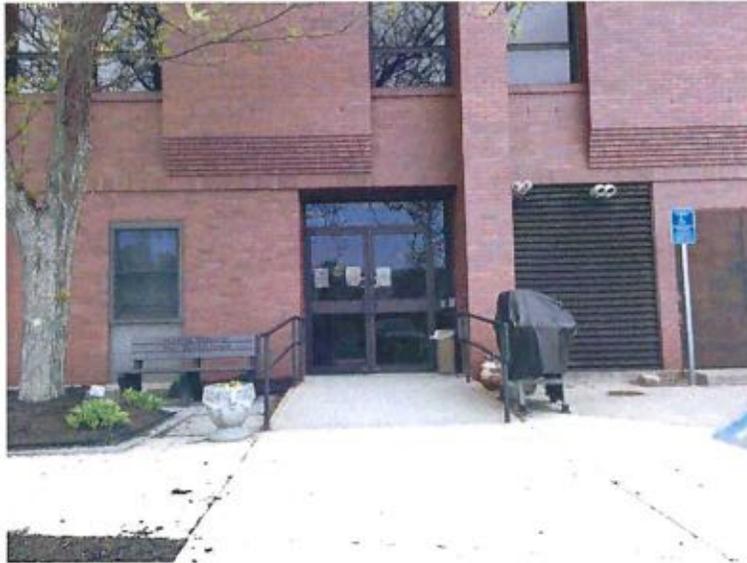
The accessible route leads you to a ramp to enter the building. The ramp itself is 80" wide between the compliantly placed handrails. There are level landings at both the bottom and top of the ramp that leads you into the building. The running slope of this ramp however, is not compliant. Both ADAAG and AAB require that ramps have a slope no greater than 1 foot for every inch of rise (1:12 or 8.3%). I got measurements of 8.8% and 9.1%. The same as what I reported in the 2011 ADA Transition Plan Update

- 1) The ramp leading to the rear entrance of the Municipal Center has running slope reading of 8.8% and 9.1%

### **ADAAG – Section 404.2 – Ramp Slope**

### **AAB – Section 24.2 – Ramp Slope & Rise**

**Accessible Entrance Located at the Rear of the Municipal Center**

**Action Item** – Lengthen and regrade ramp to decrease slope to 8.3% or less.

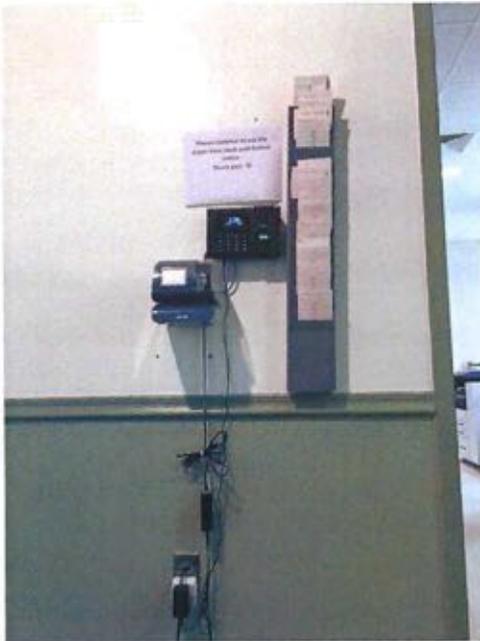
- 1) There is a time clock that protrudes 7" from the wall and is 44" a.f.f.

**ADAAG – Section 307 (Protruding Objects)**

**AAB – Section 20.6 (Accessible Route – Protruding Objects)**

**Punch Clock Protrudes 7" Into Pathway**

**Action Item** – Remove punch clock if it's no longer being used or add some type of tactile warning such as a floor plant.

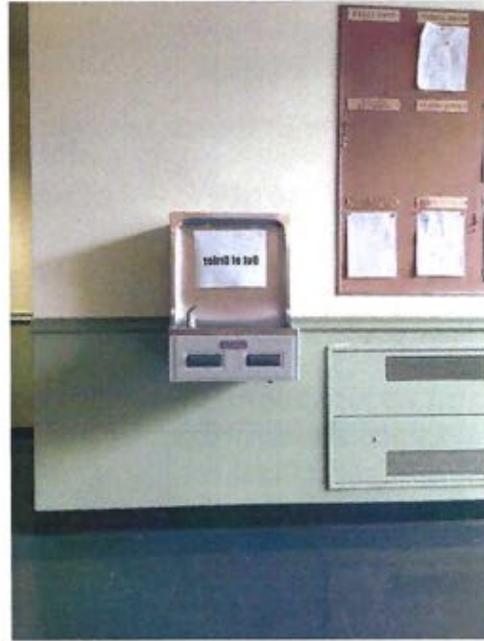
- 2) The water fountain located near the rest rooms protrudes 19" from the wall and is 28.5' (a.f.f.)

**ADAAG – Section 307 (Protruding Objects)**

**AAB – Section 20.6 (Accessible Route – Protruding Objects)**

**Water Fountain Protrudes 19"**

**Action Item** – Remove the water fountain if it's not being used. It had a sign saying "out of order" on it or add partial walls on both sides leaving at least 36" of space between them.

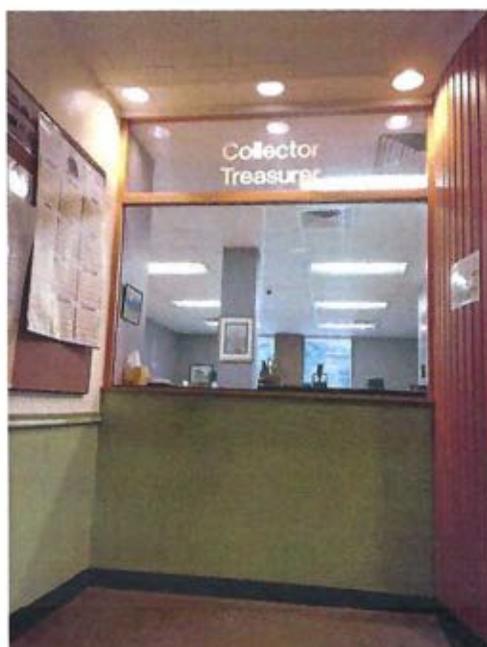
The signage throughout the first floor of the Municipal Center is mostly non-compliant. The Town Clerk, Collector/Treasurer and the Town Administrator/Selectman's office doors have test etched into the glass on the door itself. The Assessors office has a sign posted on the wall next to the door but not on the latchside. The Accountant and Treasurers office have signs posted on the latch side of the doorway that would be

ADA Compliant Signage must have raised characters that contrast with their backgrounds with Braille and mounted 60"( a.f.f) to the baseline of the sign on the latch side of the door.

#### **ADAAG – Section 703 (Signage)**

#### **AAB – Section 41 (Signage)**

**Collector/Treasurer Window Sign**

**Action Item** – Mount ADA & AAB complaint signs using the above-mentioned guidelines on the latch side of the doors 60 inches (a.f.f.) to the center of the sign.

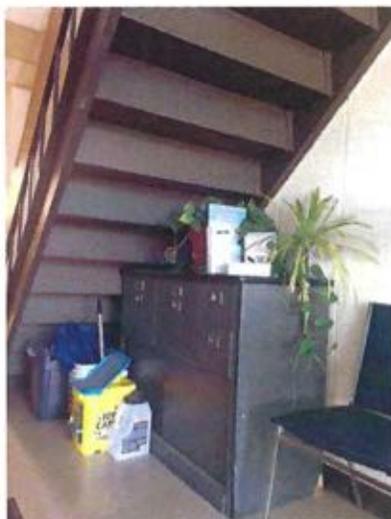
There were some potential protruding objects on the ground floor such a water fountain but there is a table used for collecting non-perishable food donations and some boxes surrounding it that alleviates that potential hazard. There is also the set of stairs leading to the first floor to your right when you enter the building that originally posed a head bumping hazard. This was addressed by placing a file cabinet and some chairs underneath as suggested in the 2011 Transition Plan update.

**Stairs Leading to the First Floor**

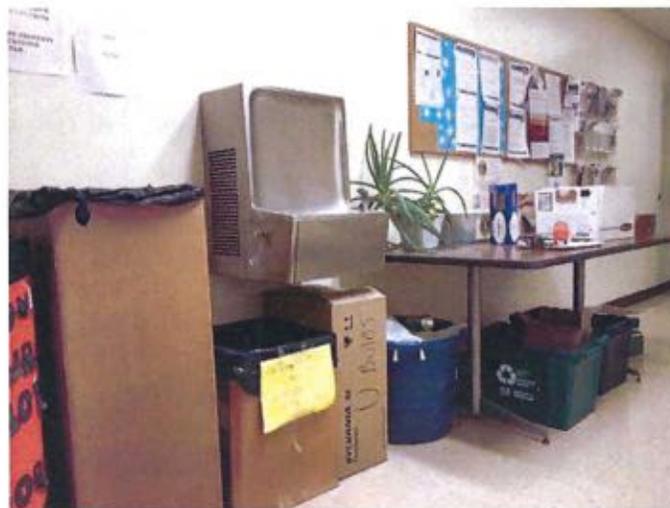
**Water Fountain Hazard Addressed With Table**

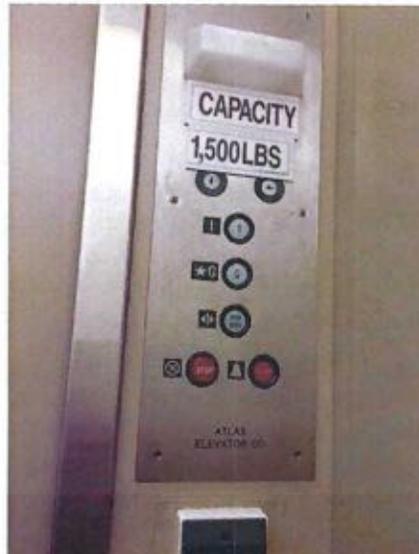
- 1) In cab controls are 51" (a.f.f) to the highest button. The maximum front approach should be 48" (a.f.f) or less.

**ADAAG Section – 407.4.6 – (Elevator Car Controls)**

**AAB Section – 28.8.2 – (Car Controls Height)**

- 2) Cab control buttons don not have Braille

**Elevator Cab Control Panel**

**Action Item** – change interior control panel with buttons no higher than 48".

**Action Item** – Add Braille to control buttons.

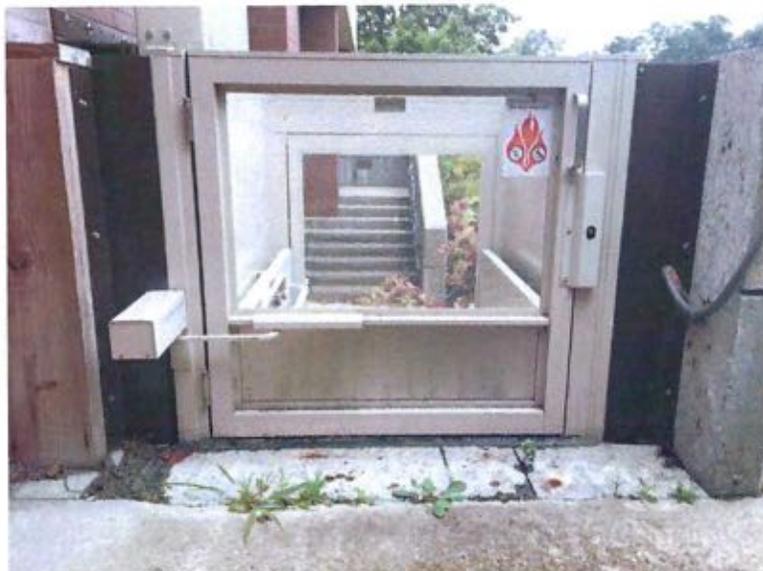
### **Vertical Lift Viewed From the Landing at the Top of the Stairs**

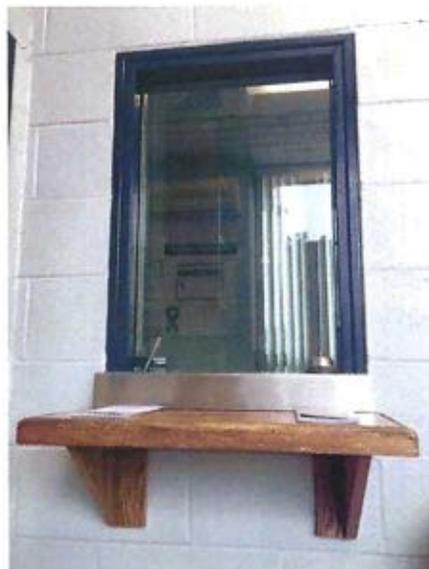
Access to the different areas and rooms in the Police & Fire Stations is plenty wide enough for a person using a wheelchair to get around. The doorways are standard 36' wide with compliant lever style door handles. The service window is a compliant 36" (a.f.f.). To my knowledge this is the only service counter/window that is compliant in height.

**Blackstone Police & Fire Station Service Window**

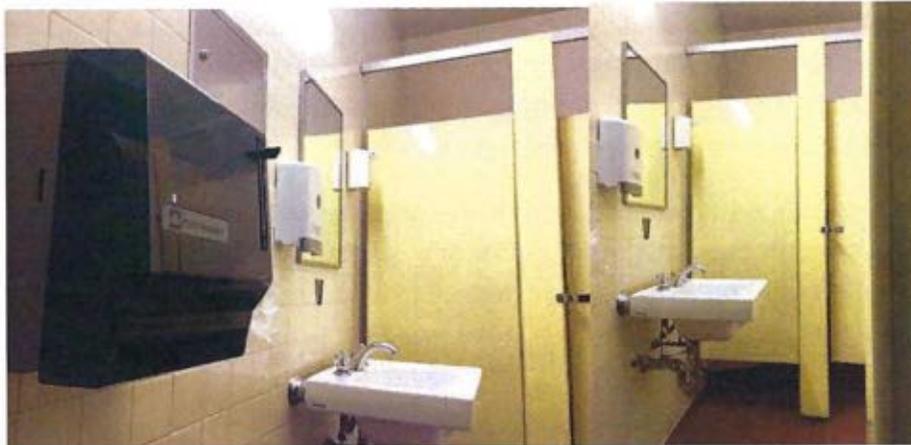
**First Floor Men's rest Room at Police & Fire Station**

In order to create an accessible bathroom, the existing areas of non-compliance must be addressed as follows: signage -install accessible compliant signage on the latch side of the door with appropriate finish and contrast and character height and proportions, raised and brailed characters should also be included, signage should be mounted at 60" above finish floor (a.f.f.) to the centerline of the sign with tactile characters a minimum of 48" a.f.f.; door - install lever style hardware; water closet - replace water closet and install such that flush valve is on approach side and centerline

and height requirements are met; grab bars – install 42" long bars at between 33" and 36" a.f.f. and at proper wall setbacks; mirror – lower mirror such that mirror bottom is no more than 40" a.f.f.; toilet paper dispenser – relocate to within acceptable reach range; sink – replace faucet to meet operability requirements;

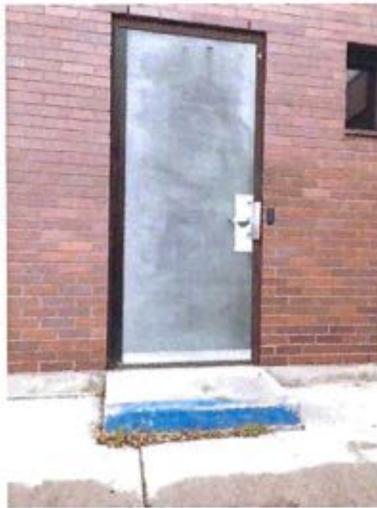
### **Ground Level Entrance to the Police Holding Cells**

**Action Item** - Modify entrance into building and perform required modifications for accessible compliant ramp and entry. This should include the construction of a ramp w/4' of clear space between handrails. The handrails shall be continuous on both sides of the ramp, 1-1/4" to 1-1/2" in outside diameter, and round or oval in shape; handrails to be provided in pairs, one at a height of 34" - 38" above the ramp surface and the lower handrail at a height between 18" and 20"; handrails to be 1-1/2" from the mounted surface; handrails should extend 12" beyond the bottom of the ramp. The ramp shall not exceed a running slope of 8.3% nor a 2.0% cross-slope. A 60" x 60" level area at the ramp base and top is required.

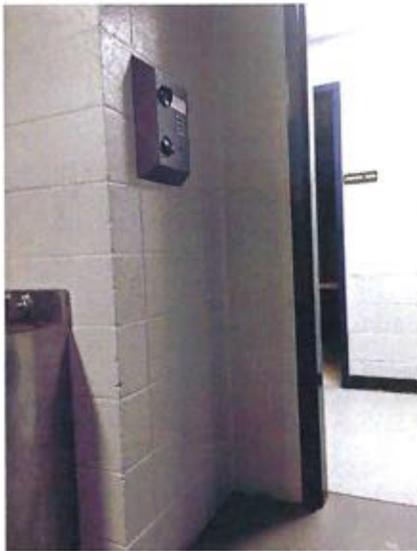
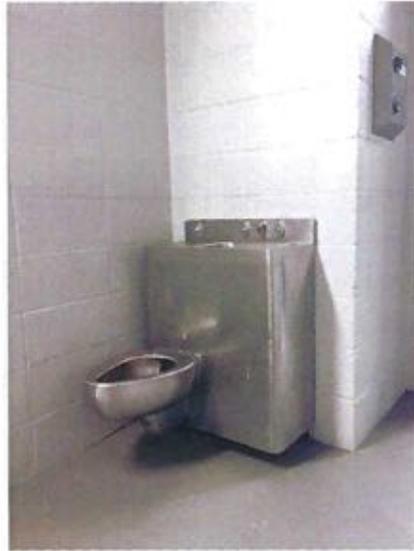
The holding cells are also located on the ground floor. And the entrance has a compliant 34" of clear space for easy entry for someone using a wheelchair. There is plenty of maneuvering clearance to access the bed and the toilet. The only concern I have regards the wall hung telephone. The receiver is built into the phone itself like an intercom and is mounted 60" (a.f.f.) to the top making it difficult for a person using a wheelchair to access it. I would suggest that a phone in one of the holding cells be lowered to 48' (a.f.f) to the top.

### **Holding Cell Phone Communication Device and Toilet**

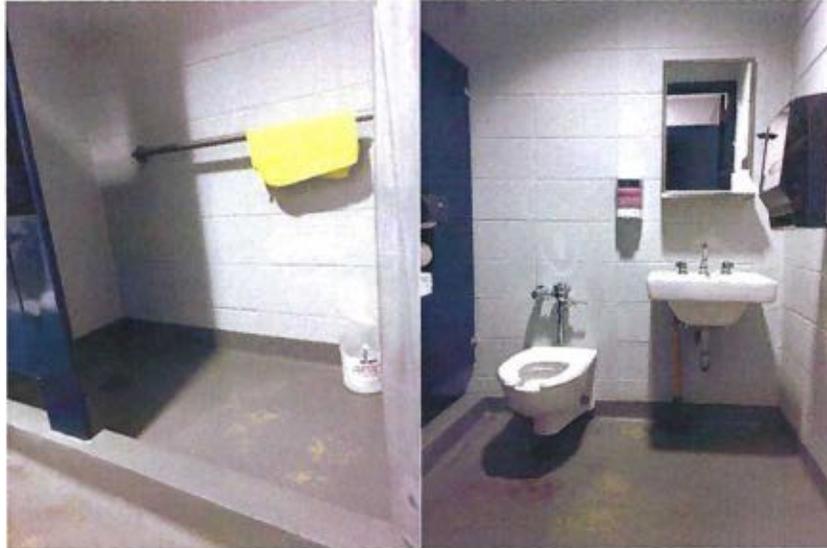
There is also a restroom located across from the holding cells that includes a shower. This is for the Police officers to use. It is much more accessible than the restrooms on

**Ground Floor Police Station Restroom**

the first floor. To bring this restroom into complete compliance, add pipe insulation under the sink, install 42" long grab bars at between 33" and 36" (a.f.f) and at proper wall setbacks; lower the mirror such that mirror bottom is no more than 40" (a.f.f.).

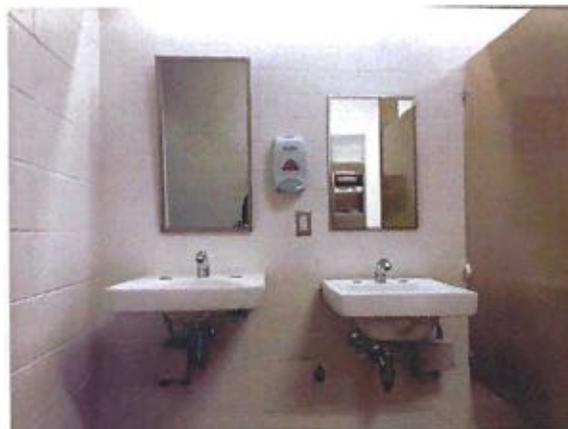
**First Floor Women's Restroom Lavatories**

5) Lavatory soap dispenser is 47 inches (a.f.f) above the lavatories. Dispensers over an obstruction must be no higher than 44 inches

**Action Item – Install insulation on the sink piping**

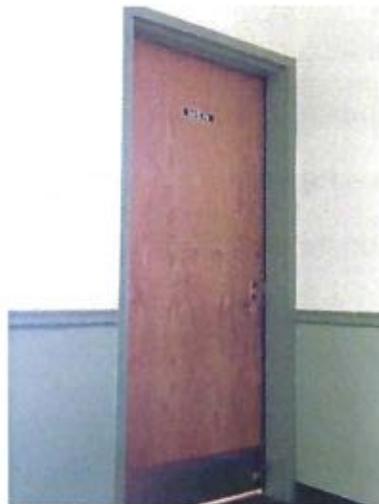
**First Floor Men's Restroom Door**

- 2) There is only three inches of maneuvering clearance beyond the latch side of the door due to it being so close to the wall. There should be at least 18 inches.

**Action Item** - Install accessible compliant signage on the latch side of the door wall with appropriate finish and contrast and character height and proportions, raised and Brailled characters should also be included, signage should be mounted at 60" above finish floor (a.f.f.) to the centerline of the sign with tactile characters a minimum of 48" (a.f.f.).

**Action Items** – 1) Adjust or replace door closer. 2) Install an automatic door opener.

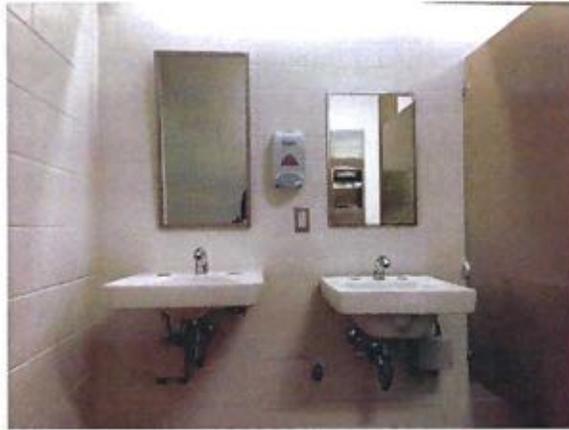
### **First Floor Men's Restroom Lavatories**

- 5) Lavatory soap dispenser is 50 inches (a.f.f) above the lavatories. Dispensers over an obstruction must be no higher than 44 inches.

**Action Item** – Install insulation on the sink piping

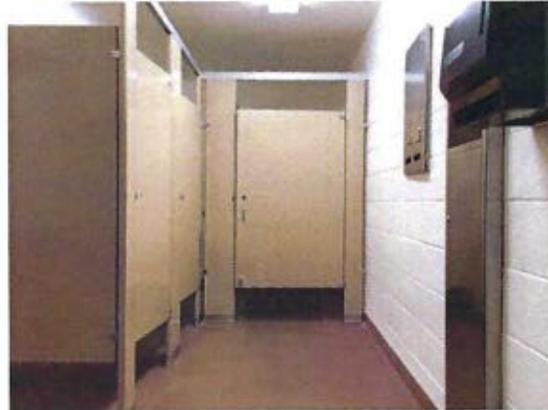
no issues for people using wheelchairs to see themselves. The accessible lavatory is mounted at a compliant 33 inches (a.f.f) with 28 inches of knee clearance and the facets are automatically activated.

**Ground Floor Women's Restroom Interior**

- 4) The lavatory pipes do not protect against leg contact

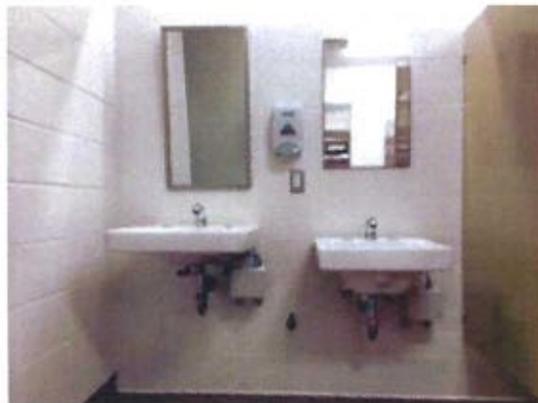
### **Women's Ground Floor restroom Lavatories**

**Action Item – Lower soap dispenser to 44 inches (a.f.f) or less.**

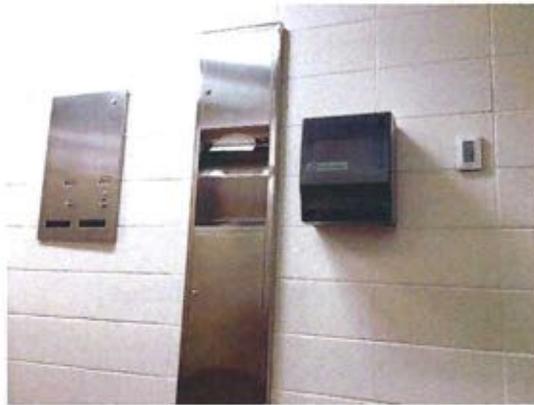
- 6) Paper Towel dispenser is 60 inches (a.f.f) to its operable part. The updated ADA accessibility guidelines require operable parts to be mounted no more than 48 inches for both forward and side reach. In addition, there is a sanitary dispenser that is mounted above the maximum allowed reach range.

### **Ground Floor Women's Restroom Dispensers**

**Action Item – Lower paper towel and sanitary dispensers to 48".**

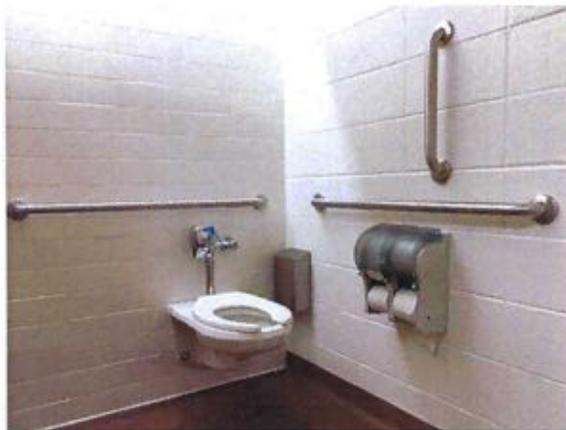
The accessible toilet stall at 65" X 113" is more than compliant in dimensions, maneuvering clearance and the stall door has a 34 inch clear opening when it is opened at 90 degrees. The stall door self closes and has compliant hardware that can be operated with a closed fist. The toilet is 19 inches (a.f.f) to the top and has a centerline of 18" from the near wall and flushes automatically. The grab bars are a compliant 42 inches long and are mounted at 36 inches (a.f.f). The toilet paper dispenser is also mounted at a compliant height and reach range.

**Ground Floor Women's Restroom Accessible Stall Interior**

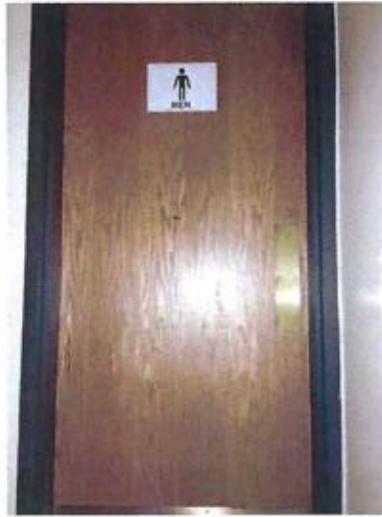
### **Men's Ground Floor Restroom Door**

**Action Item** – Add automatic door opener

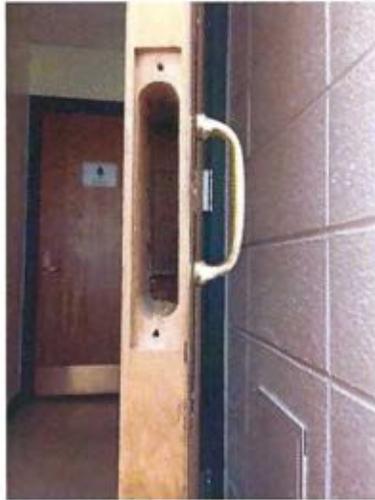
The doorway is a standard 36 inch door that has 33" of clear space when open 90 degrees. However, the door requires 8 pounds of force to open and it closes in three to four seconds. In addition, the handle on the inside of the door is difficult to operate with a closed fist because the loop opening isn't large enough to fit your hand through.

### **Ground Floor Men's Restroom Interior Door Handle**

**Action Items** – 1) Adjust or replace door closer. 2) Install an automatic door opener. 3) Replace interior door handle with either a lever style or one with a bigger loop.

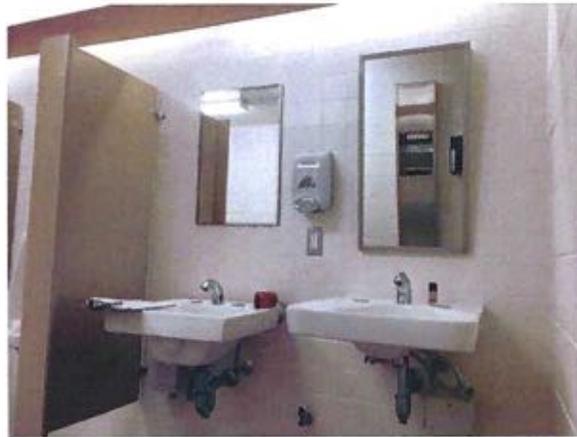
### **Ground Floor Men's Restroom Lavatories**

**Action Item** – Lower soap dispenser to 44 inches (a.f.f) or less.

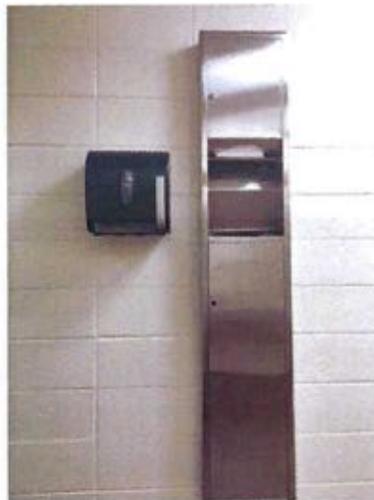
- 6) Paper Towel dispenser is 50 inches (a.f.f) to its operable part. The updated ADA accessibility guidelines require operable parts to be mounted no more than 48 inches for both forward and side reach.

### **Ground Floor Men's Restroom Paper Towel Dispensers**

**Action Item – Lower paper towel and sanitary dispensers to 48".**

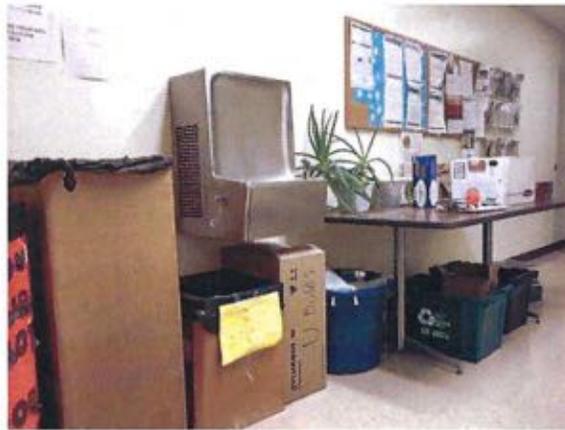
### **Ground Floor Drinking Fountain**

**Action Items** – 1) Lower drinking fountain two inches. 2) Remove boxes from underneath the drinking fountain.
