June 28, 2011

Sandy Lamoine  
Administrative Assistant  
Town of Blackstone  
Municipal Office Building  
15 St. Paul Street, Blackstone, MA 01504

### **Americans with Disabilities Act Updated Transition Plan for the Town of Blackstone MA**

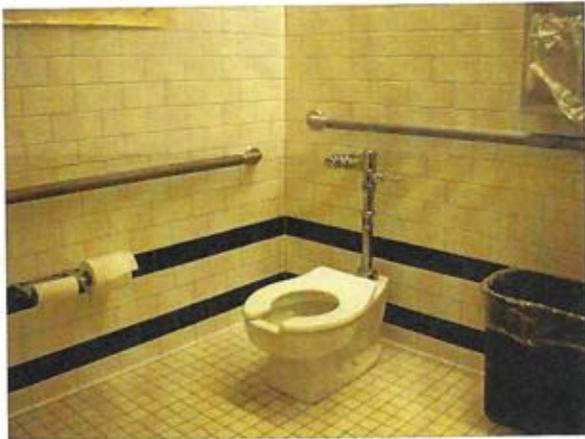
The door opening force for both the men's and women's room still around 10lbs to open. In addition, the force required to operate the lavatory faucet in the men's is 10lbs and should only be five.

There is a rest room set up for children as well. The new ADA Access Guidelines have different heights and toilet centerlines based on the age group.

The next time renovations take place in the children's rest room, refer to the chart below for toilet, dispenser and grab bar height for the age group most appropriate for this children's section.

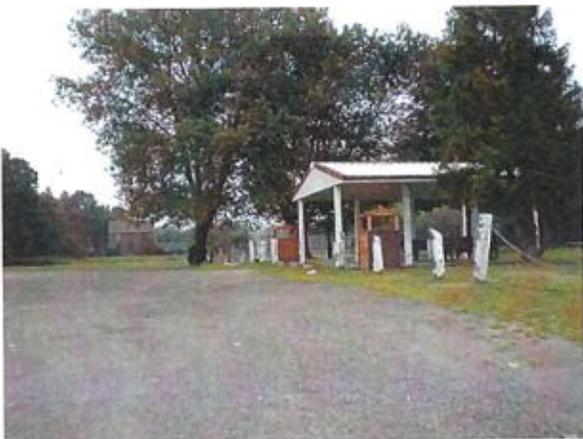
No parking area improvements have been made.

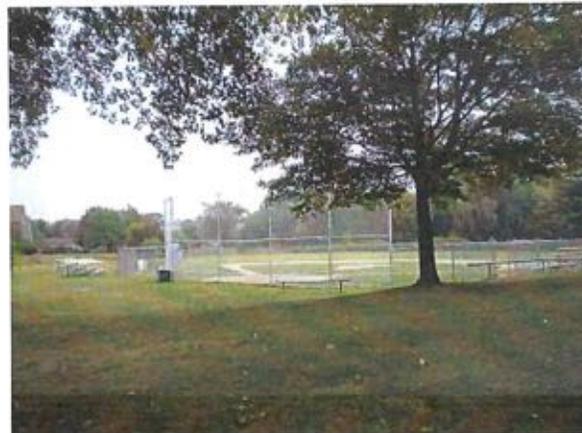
Views of Terbesi Park showing lack of paved paths of travel.

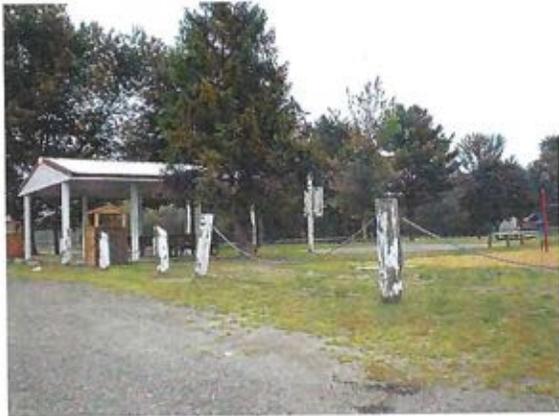
There are picnic tables under the pavilion that are not accessible for people who use wheelchairs. In addition, there is no accessible route to the pavilion and there is a 2 to 4" transition from the unpaved ground surface to the concrete pavilion floor that creates a barrier for wheelchair users to on to it.

Create an accessible path of travel from the parking area straight to the pavilion that has no change in surface level and if room permits, add an accessible picnic table. If there is not enough

room for an additional table under the pavilion, replace one of the non-accessible tables with an accessible one.

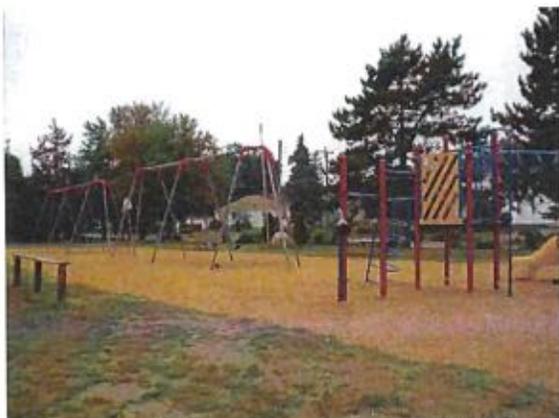
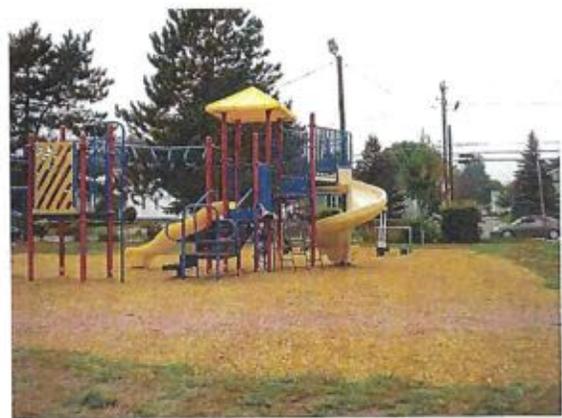
Playground pictures from August 2010

The existing play area is equipped with both ground level and elevated components. However, these may not be in the proper proportions to meet the ADA. Additionally, while the ground surfaces are soft, designed to limit injuries from falls, they do not provide the "firm, stable and slip resistant" surface required for wheelchair or crutch maneuvering. Total numbers of components are used to determine the requirement for ramps, maneuvering space, forward and side reach, heights, clearances at entry points, transfer supports, etc are some of the requirements for play area compliance with the ADA. Should any alterations or additions be made to these play areas, a detailed evaluation of existing equipment as well as professional recommendations regarding the new component choices and layouts are strongly recommended.

It appears that some new playground items may have been installed since the original ADA Transition Plan of 2006, or they have been refurbished. In addition, the ground surface consists of wood chips that also appear to have recently applied. If that is the case, ADA violations have occurred. Wood chips are NOT an acceptable ground surface either in playgrounds or on paths of travel because they do not provide a firm, stable and non-slip surface. Acceptable replacement materials include interlocking rubber matting, plastic matting and poured in place rubber surfacing.

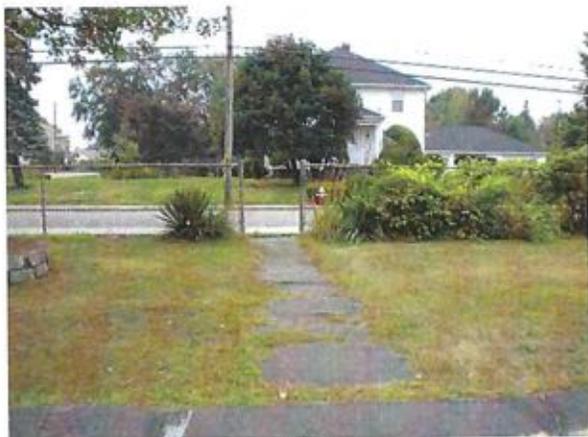
There is a walkway from the Rathbun Street sidewalk that leads into the park playground area that is in complete disrepair.

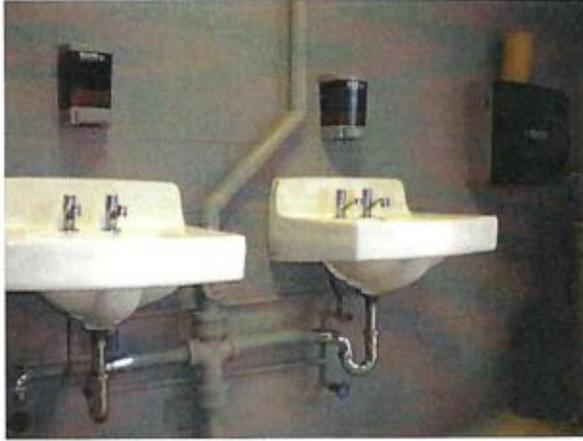
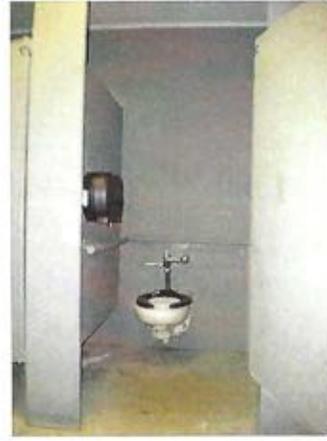
There are no stalls in either restroom that provide the minimum dimensions of 5' X 5" clear of door swing.

The rims of the urinals in the men's room exceed the maximum compliant height of 17" by 4" for an accessible urinal.

Reconfigure one toilet stall in the men's and women's room so that it provides a minimum dimension of 5' X 5' clear of door swing or 5' X 6'.

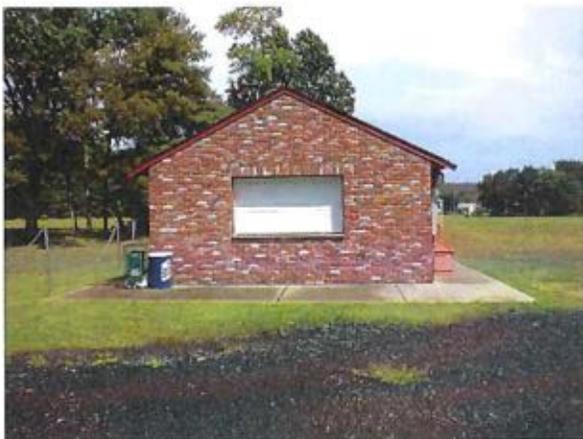
None, the concession window remains over 34" AFF.

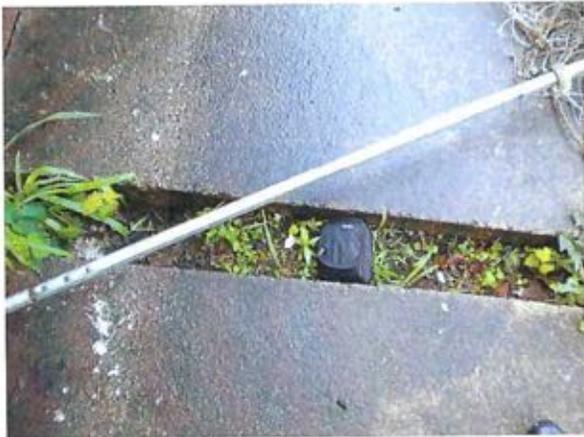
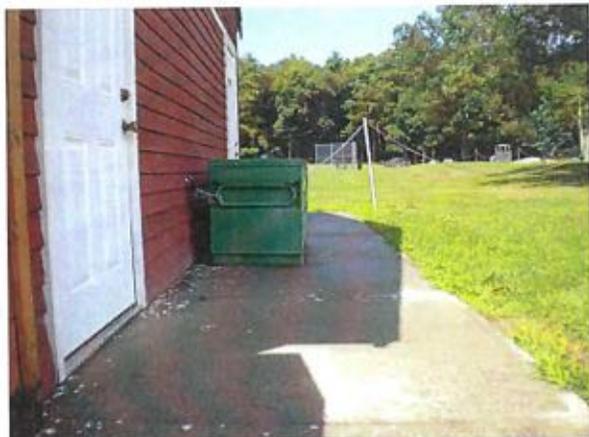
- 2) The walkway that surrounds the concession/toilet facility has four inch gap between concrete slabs. In addition, there are storage containers and debris that reduce the 36" minimum width of an accessible route.

**Action item(s) suggested** -Fill in gaps between the concrete slabs and remove storage containers and debris from the walkway to the concession stand and restrooms.

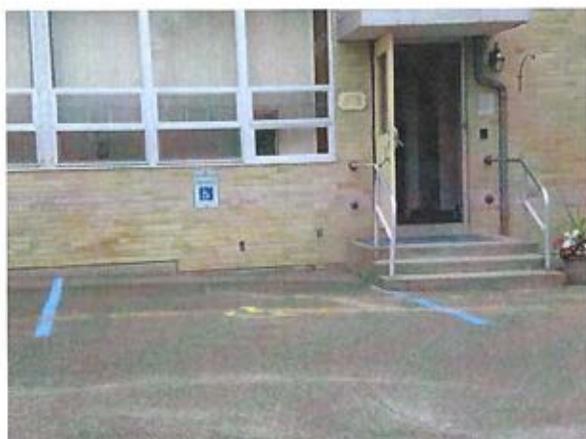
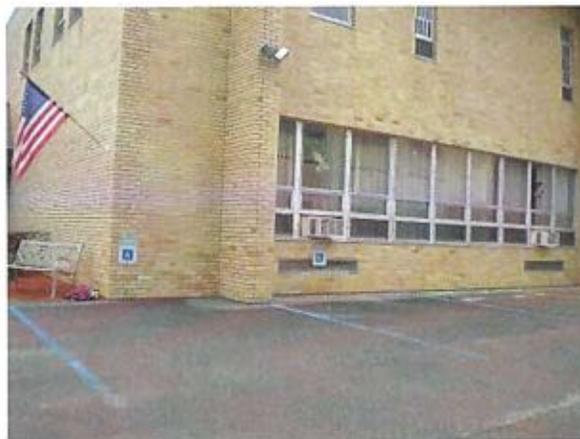
- 1) The handicapped parking spaces lack 5' access aisles for car accessible spaces and an 8' access aisle for a van accessible space
- 2) There is no accessible parking space designated as 'van accessible' with signage.
- 3) The signage designating the handicapped parking spaces are compliant. However, they are mounted at 38" AFF and are obscured by vehicles parked in those spaces.

1) Re-strip the existing handicapped parking spaces and create access aisles. One of these spaces must be van-accessible. Two handicapped parking spaces may share an access aisle. Use the following measurements when re-striping:
