July 3, 2024

RE: Evaluation of Repairs for Bridge No. B-13-009
Blackstone, Massachusetts
Pare Project No. 24061.01

STRUCTURES INSPECTION FIELD REPORT

BR. DEPT. NO.
B-13-009

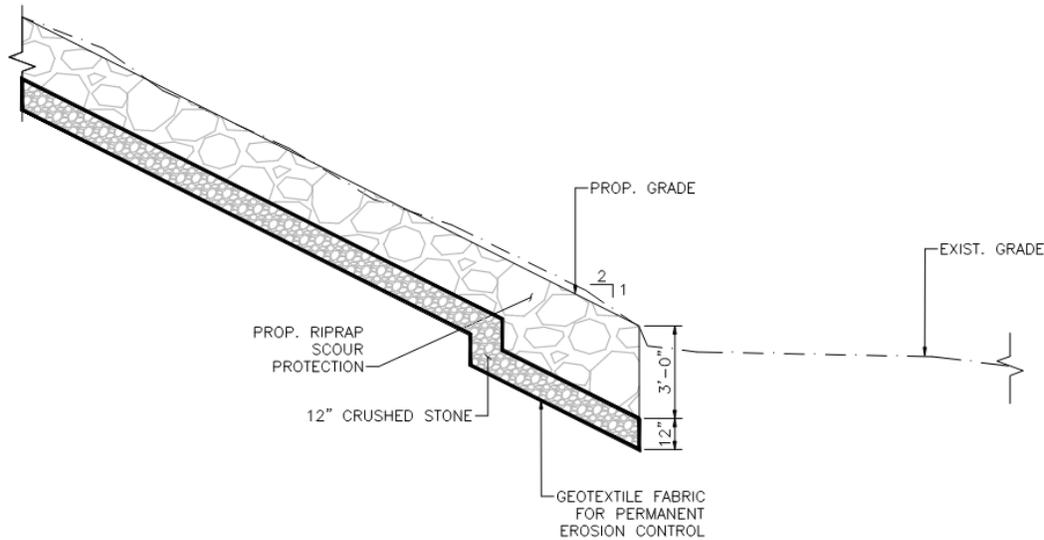
Figure 2: Example Riprap Slope Protection Section

SECTION 5 – TYPICAL PROPOSED UPSTREAM BANK PROTECTION CROSS SECTION

It is Pare’s understanding that the Town has expressed interest in installing concrete wingwalls at the corners of the bridge. However, significant costs are associated with the installation of wingwalls. Typical cast-in-place wingwalls at this bridge would require either pile or spread footings, control of water, and cast-in-place reinforced concrete. As a lower-cost alternative Pare recommends providing riprap as slope

protection at the embankments to restore the slopes and prevent future embankment erosion to maintain channel conditions. An example of a riprap slope detail is shown in Figure 2.

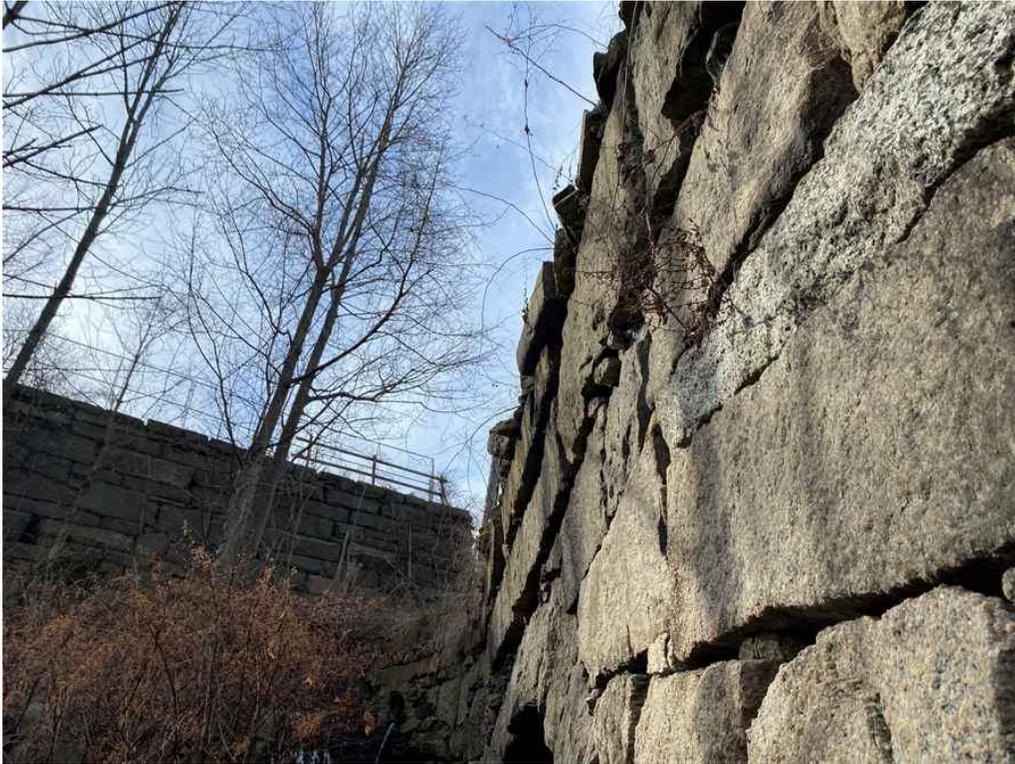
There are many stones throughout the top 2' that are up to 8" out of horizontal alignment, measuring from the arch ring out, over the west arch (span #1). **See Photo 11.**

Photo 11: South spandrel wall over span #1.

The arch is in acceptable condition, with some deterioration noted. Pare recommends pointing and grouting the masonry to maintain its current condition and prevent potential future deterioration. This repair is considered non-critical at this time.

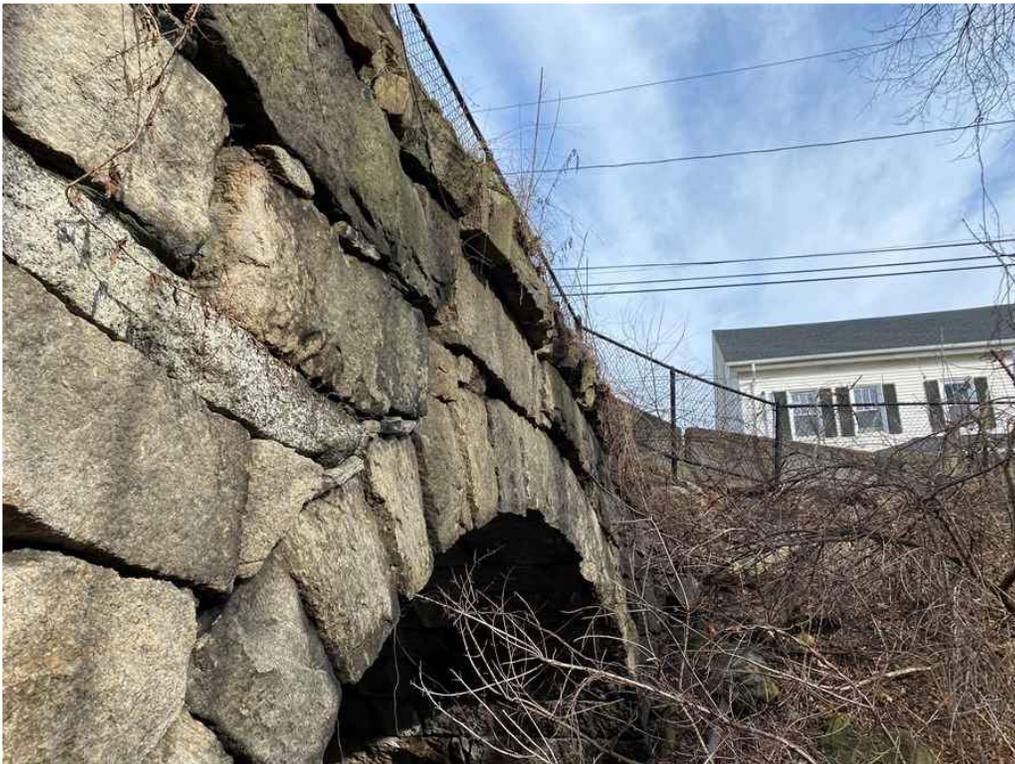
Stones over the east arch are up to 2.5" out. **See Photo 12.**

Photo 12: South spandrel wall over span #2.

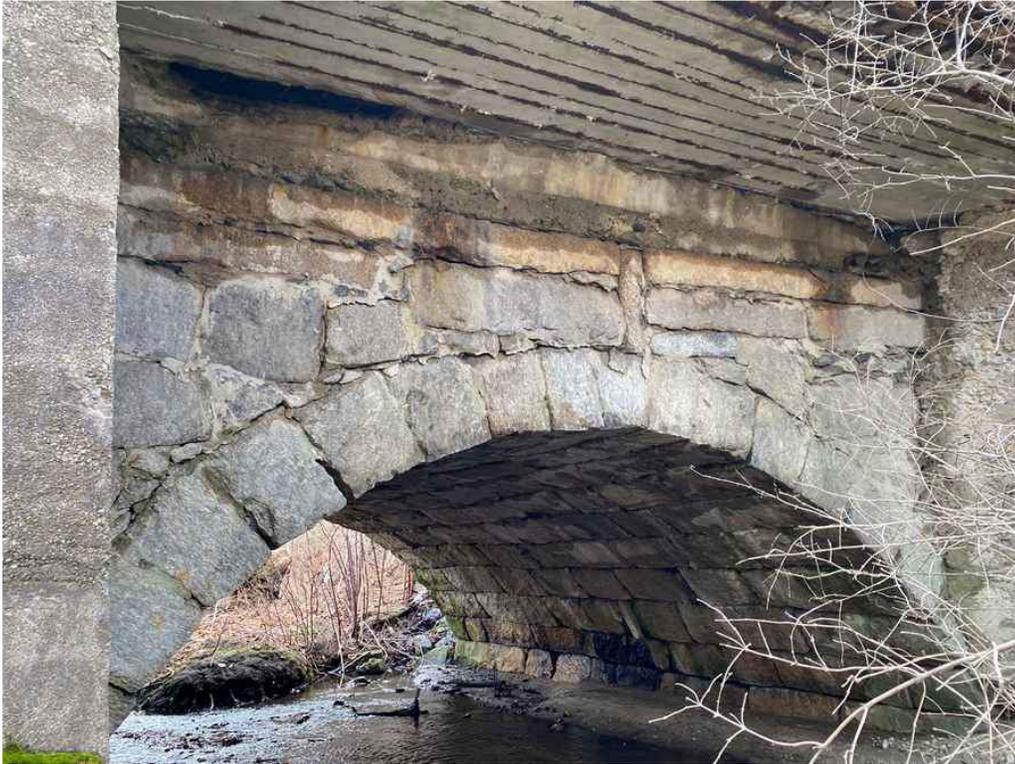
There are intermittent areas of heavy scaling to the concrete cap below the sidewalk slab, up to 5' long x 1' high x 7" deep. **See Photos 13 and 14.**

Photo 13: North spandrel wall over span #1.

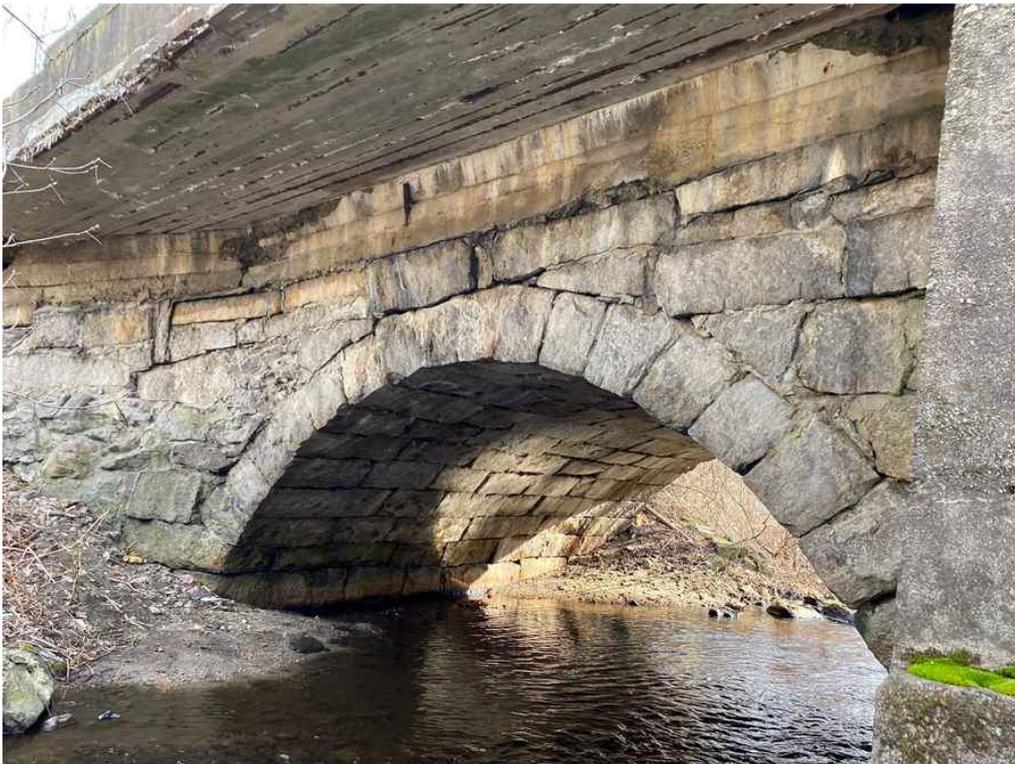
Photo 14: North spandrel wall over span #2.

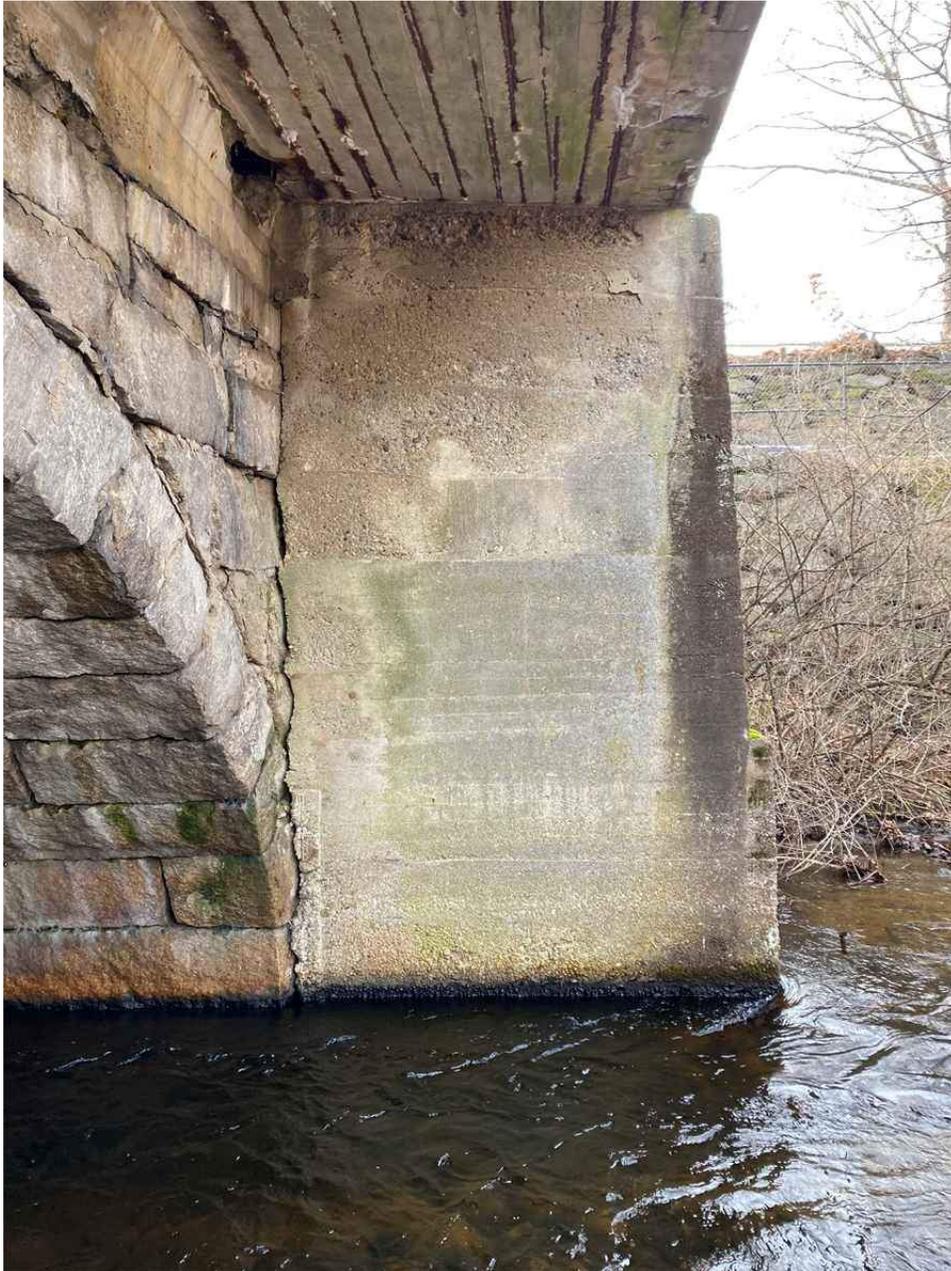
The concrete pierwall supporting the sidewalk has moderate scaling throughout. **See Photo 19.**

Photo 19: Pierwall condition. East face shown.

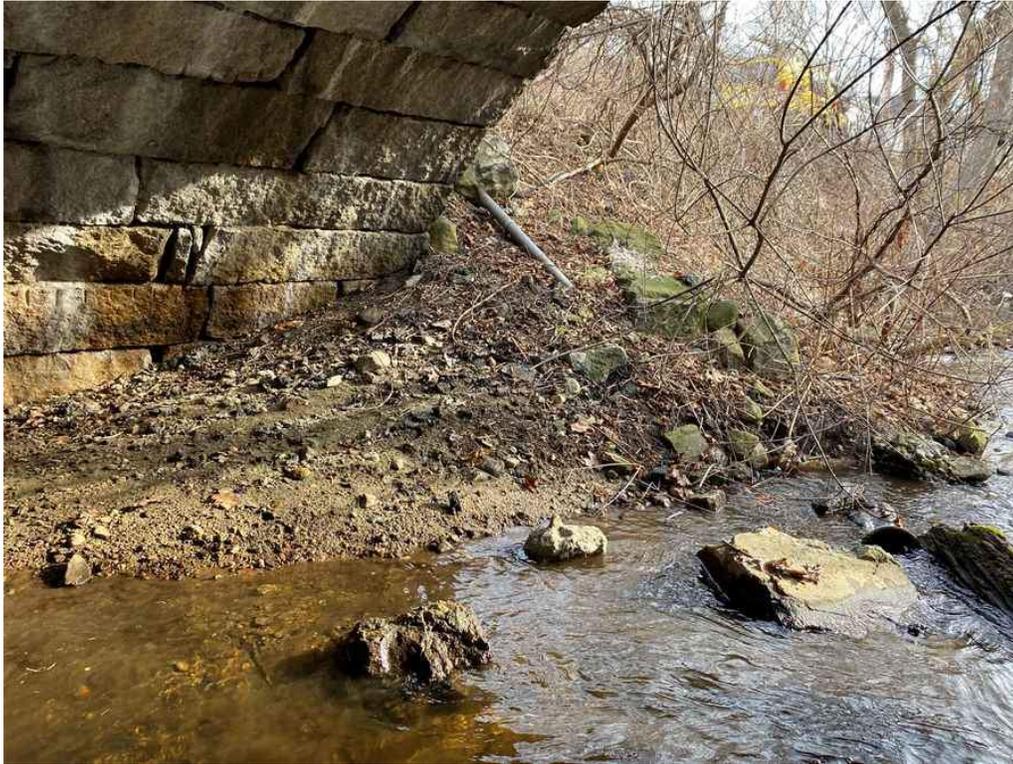
The northeast, northwest and southeast embankments have sloughed into the channel constricting flow to the center of the channel. There is heavy vegetation growth at these locations. **See Photos 20 through 22.**

Photo 20: Southeast embankment.

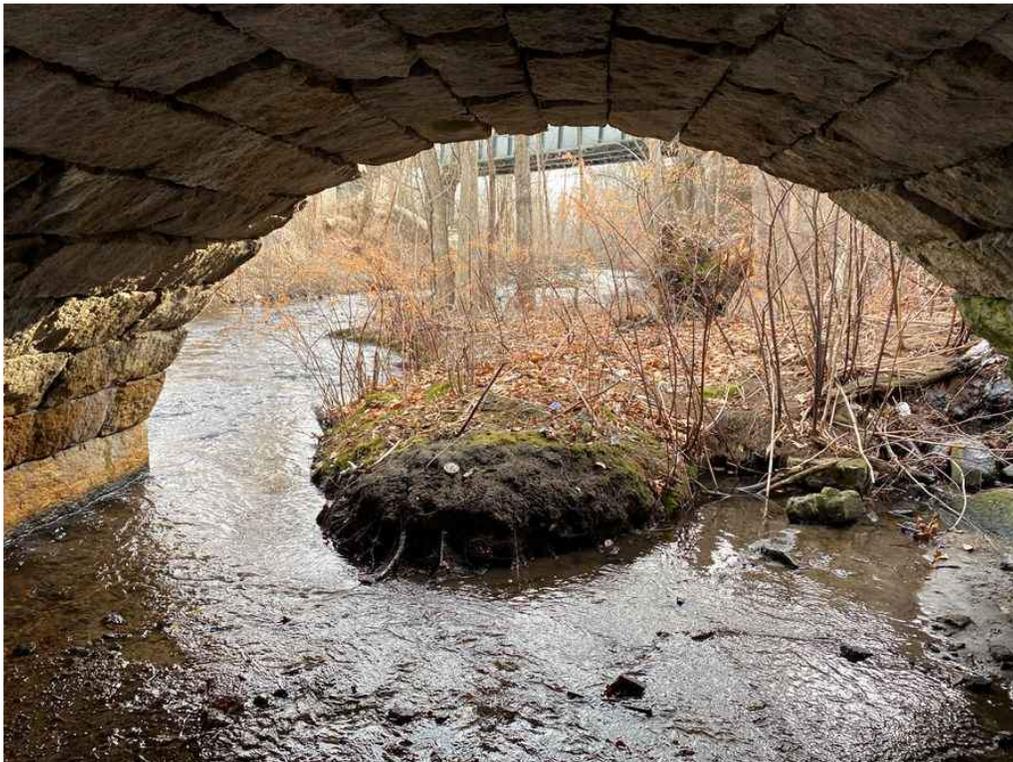
Embankment encroachment into the channel at all corners of the bridge has constricted the flow to the center of the channel around the pier. There are large vegetated islands at both the upstream and downstream ends of span #1. **See Photos 21 and 22.**

Photo 21: Southwest channel.

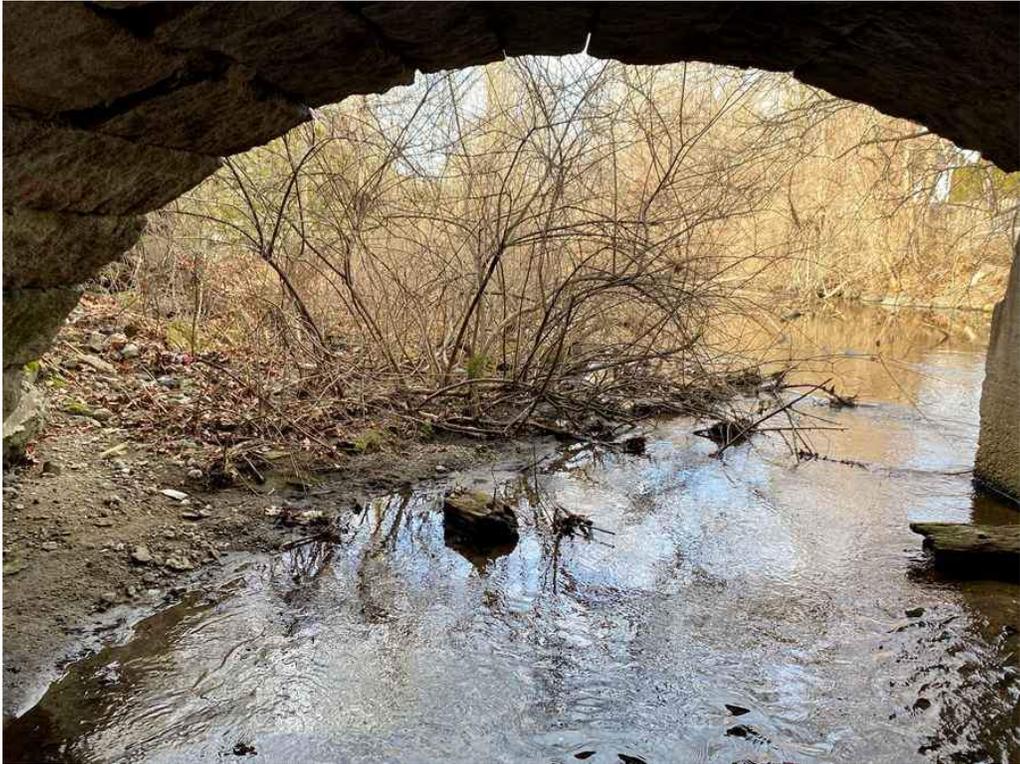
There is heavy vegetation growth at the upstream end of the west arch. **See Photo 22.**

Photo 22: Northwest channel.

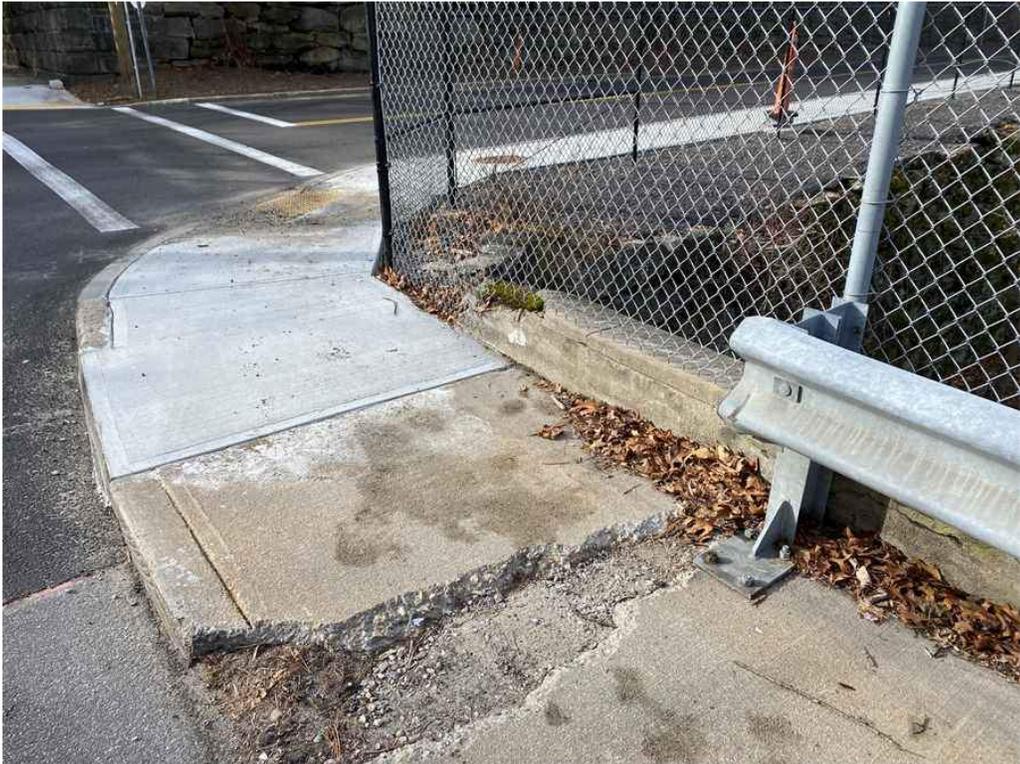
The southeast, southwest, and northwest approach traffic safety features do not have end treatments (blunt ends). **See Photo 23.**

Photo 23: Northwest approach guardrail.
